## SSSES PHASE I

## CITY OF HALLANDALE BEACH, FLORIDA

FY 2018

DEP Clean Water SRF Project No. \*\*\*

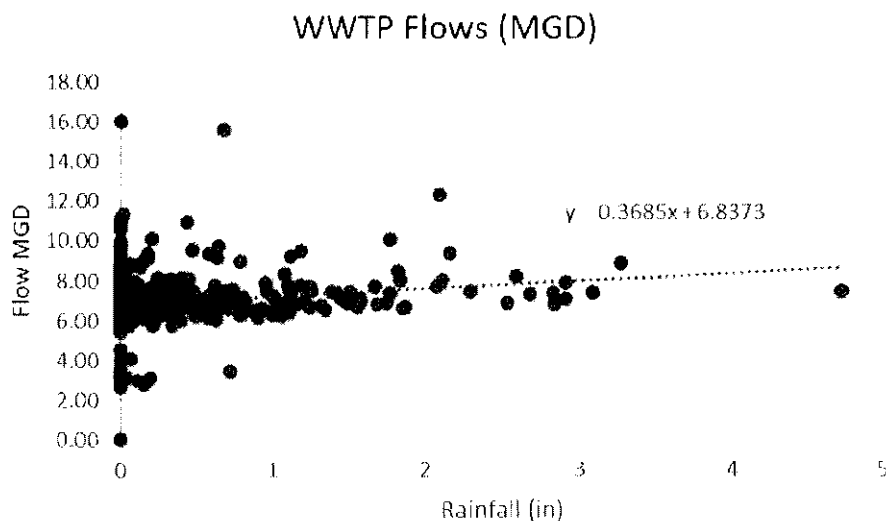
Inflow is a completely different issue. Where there are peaks in wastewater flows that match rainfall, inflow would appear to be a more likely candidate for the cause of the peaks than infiltration from pipes that are constantly under the water table. Inflow is directly responsible for sanitary sewer overflows. Inflow is surface connection to the sewer system – manhole covers, manhole rings, open cleanouts and broken services. Inflow is caused by surface corrections and is usually identified with smoke testing. Figure 1.8 shows that wastewater flows increase with rainfall, indicating that inflow exists on the system.

Figure 1.8 Wastewater Flow data – total system versus rainfall, indicating inflow exists on system

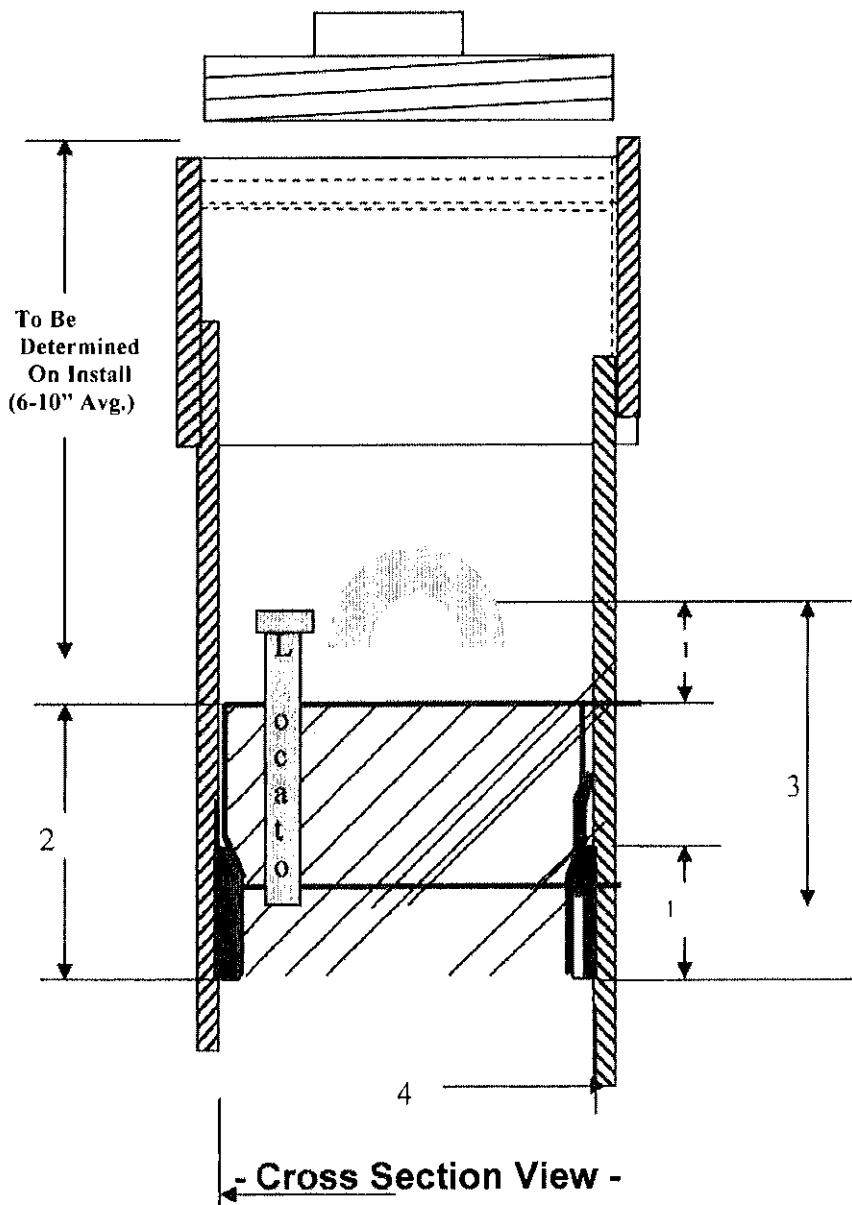
Figure 7.1 – LDL Plug installed in cleanout
