SSES PHASE I

CITY OF HALLANDALE BEACH, FLORIDA

FY 2018

DEP Clean Water SRF Project No. ***

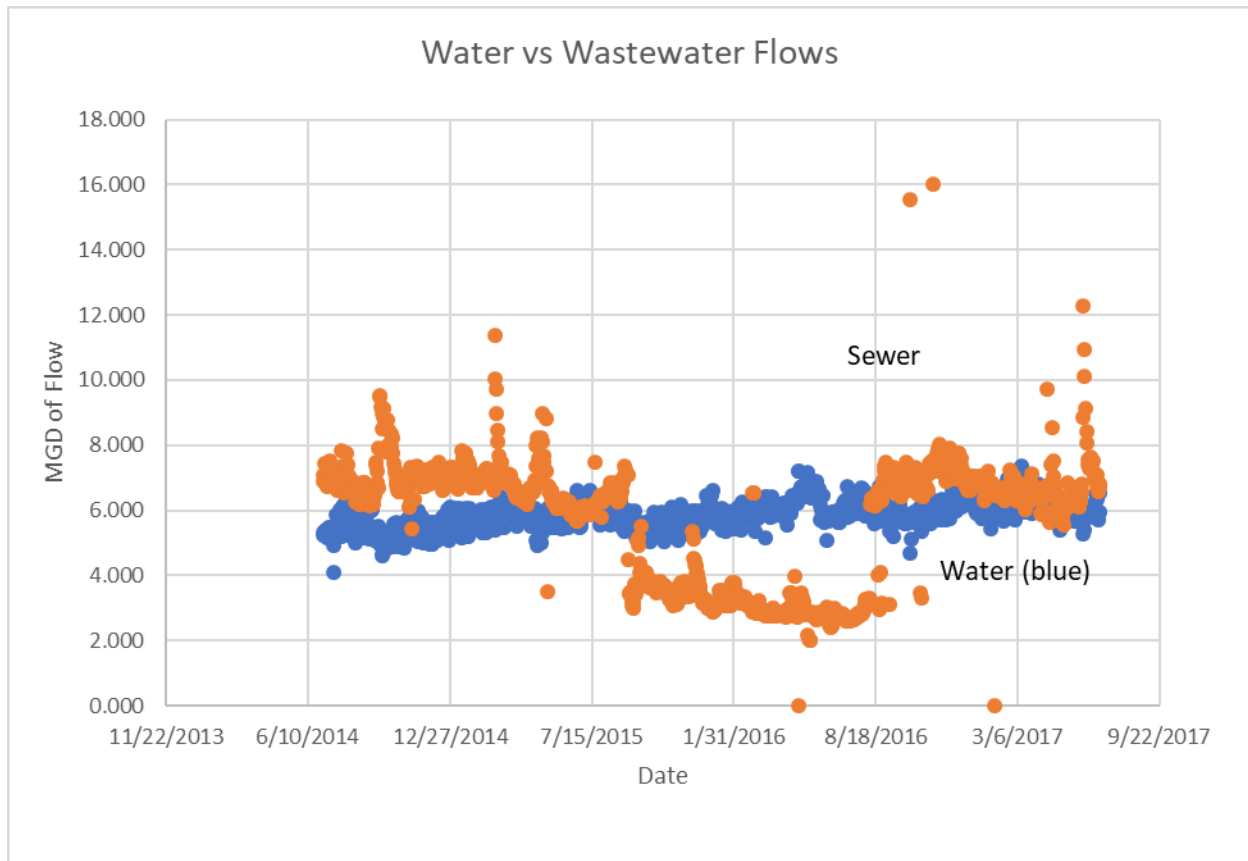
Figure 1.6 Water and Wastewater Flow comparison, 2014-2017 - note largest meter out of service in 2015/16

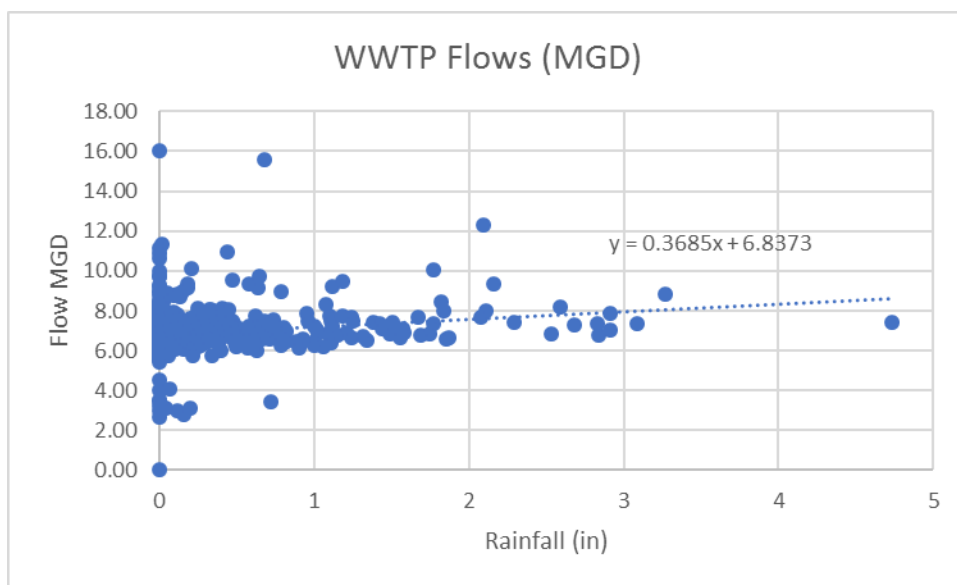
Inflow is a completely different issue. Where there are peaks in wastewater flows that match rainfall, inflow would appear to be a more likely candidate for the cause of the peaks than infiltration from pipes that are constantly under the water table. Inflow is directly responsible for sanitary sewer overflows. Inflow is surface connection to the sewer system – manhole covers, manhole rings, open cleanouts and broken services. Inflow is caused by surface corrections and is usually identified with smoke testing. Figure 1.8 shows that wastewater flows increase with rainfall, indicating that inflow exists on the system.

Figure 1.8 Wastewater Flow data – total system versus rainfall, indicating inflow exists on system

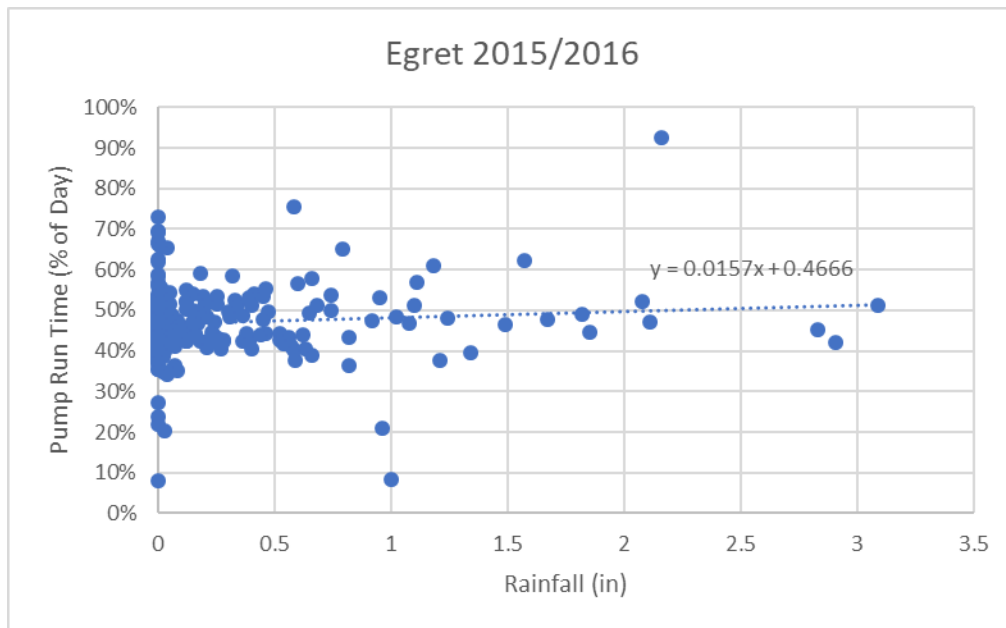
Figure 3.2 – Inflow for 2015-2016 – the increasing slope indicates flows increased with rainfall - Lift Station 1 Service Area

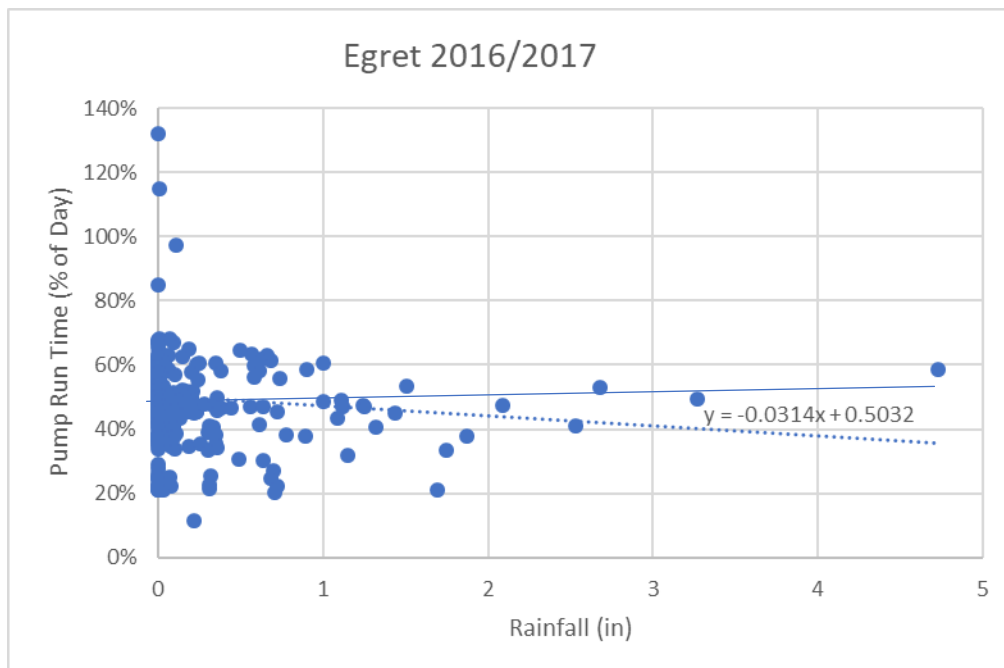
Figure 3.3 – Inflow for 2016-2017 – the regression slope is negative, but note some early high run times. The actual slope (solid line) slope indicates flows increased with rainfall- Lift Station 1 Service Area

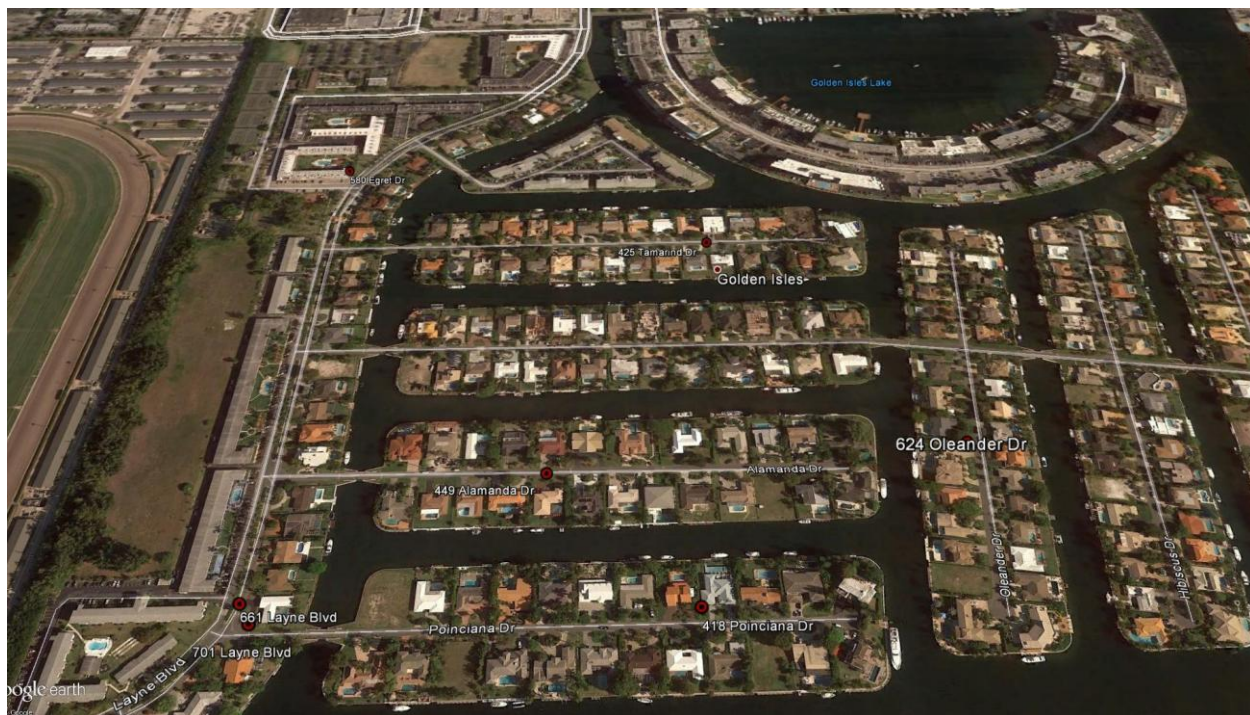
Figure 3.6 Location of Smoke test leaks - Lift Station 1 Service Area

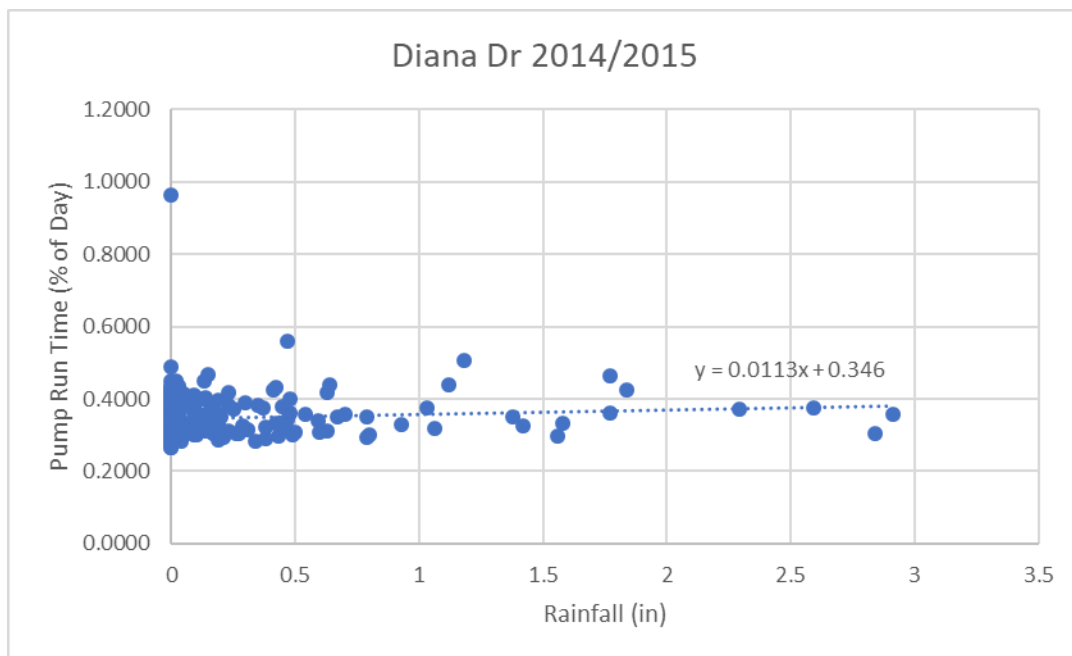
The midnight run showed that there was a leak coming in above Manhole 02-013, and in the lined areas from Manhole 02-004 to 02-008. This was among several lined areas of the City that had liner issues. piping in this service area needed to be televised. Several areas along Hallandale Beach Blvd and Diplomat Parkway need to be televised.

Figure 3.7 – Inflow for 2014-2015 – the increasing slope indicates flows increased with rainfall

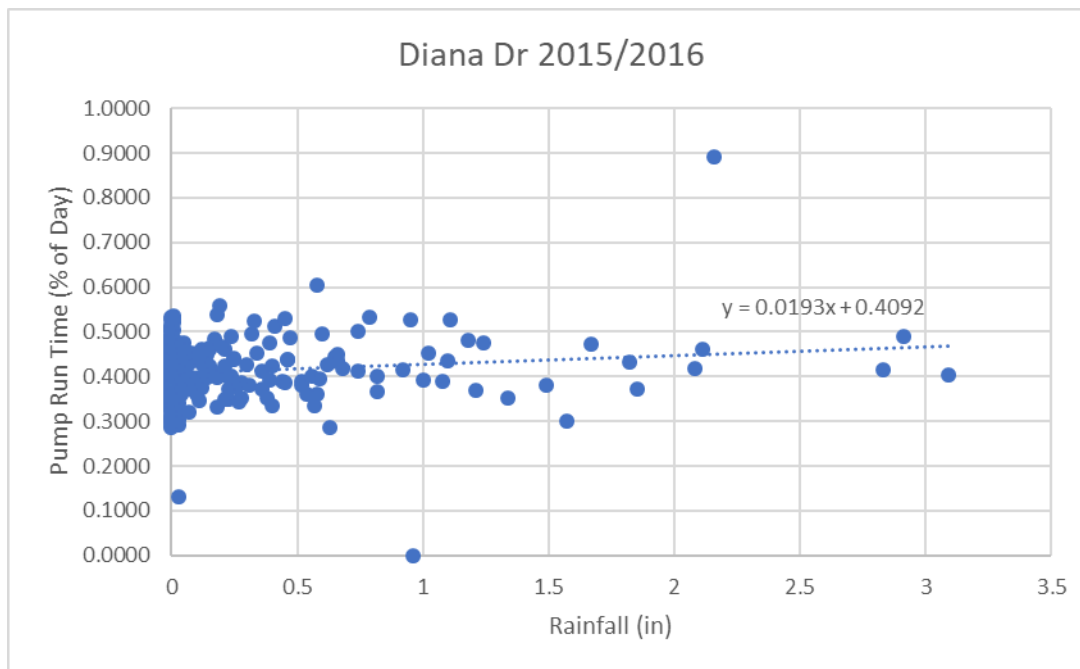
Figure 3.8 – Inflow for 2015-2016 – the increasing slope indicates flows increased with rainfall - Lift Station 2 Service Area

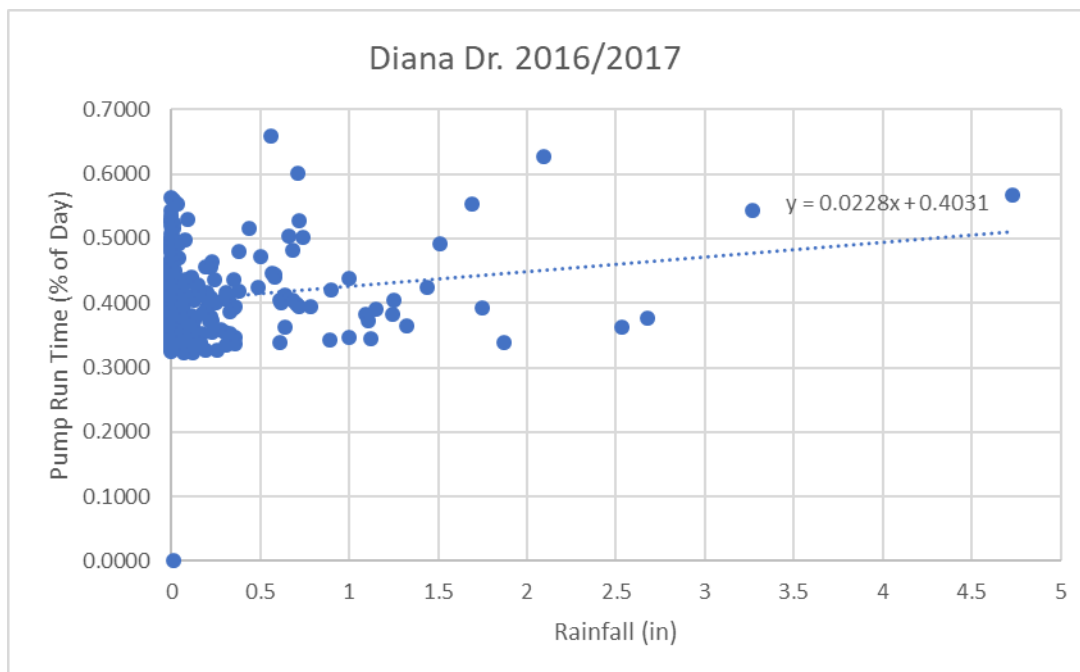
Figure 3.9 – Inflow for 2016-2017 – the regression slope is negative but note some early high run times. The actual slope (solid line) slope indicates flows increased with rainfall - Lift Station 2 Service Area

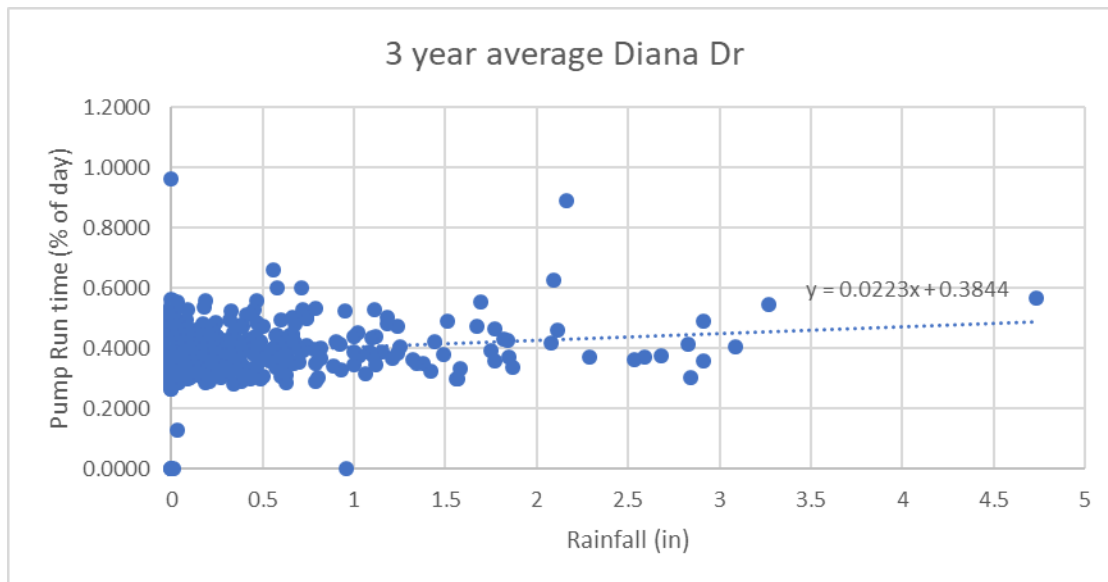
Figure 3.10 – Average graphic foe Inflow for 2014-2017 – the increasing slope indicates flows increased with rainfall- Lift Station 2 Service Area

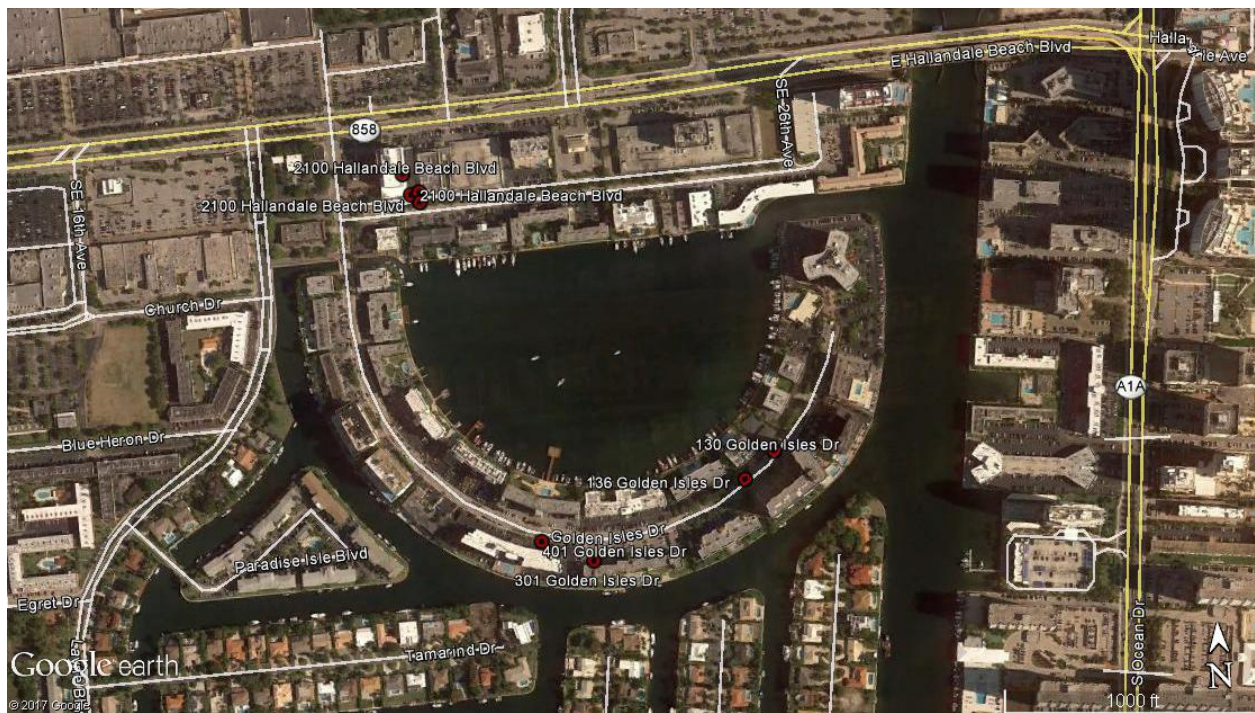
Figure 3.12 - Location of Smoke test leaks - Lift Station 2 Service Area

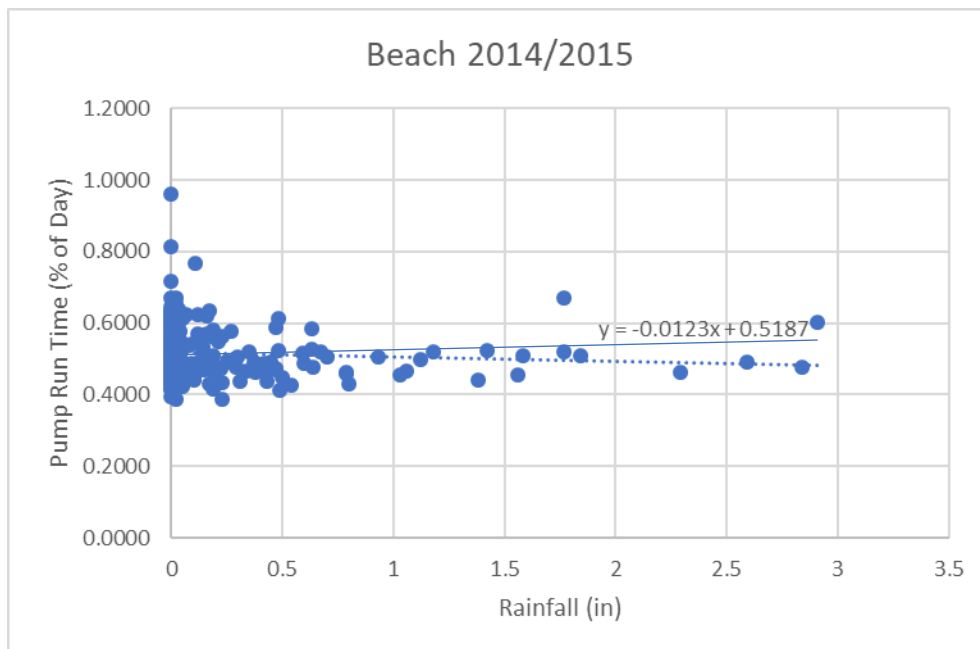
The beach piping is hard to evaluated due to the density of development. The City was televising parts of the area when this project was underway. The south end of the system was surcharged. Lift Station #3 has a top that is too low and leaks water at high tides. The parking lot piping is indicated as leaking but was submerged. Clean water was entering Manholes 03-044, in South Beach Park, and)3-035 (mineral deposits). Adult diapers were found in Manhole 03-033. Flows were entering from the west of Manhole 03-069.

Figure 3.13– Inflow for 2014-2015 – the decreasing regression slope requires further review. Eliminating some large run times with no rainfall, indicates flows increased with rainfall (solid line). Note station leaks at high tides - Lift Station 3 Service Area

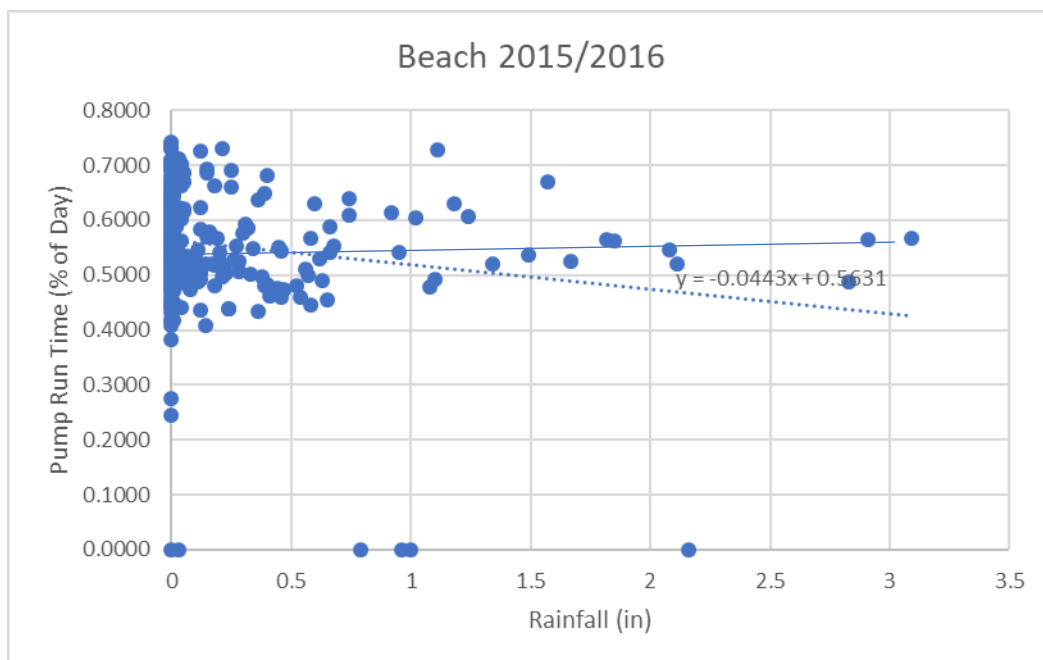
Figure 3.14 – Inflow for 2015-2016 – the decreasing regression slope requires further review. Eliminating some large run times with no rainfall, indicates flows increased with rainfall (solid line). Note station leaks at high tides. - Lift Station 3 Service Area

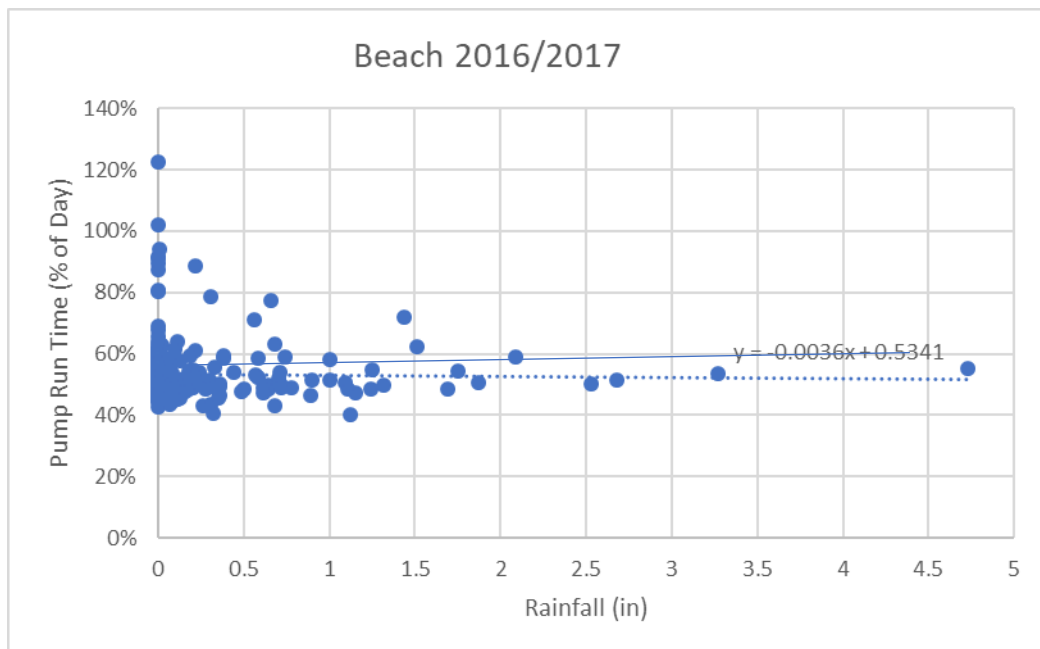
Figure 3.15 – Inflow for 2016-2017 – the slight decreasing regression slope requires further review. Note it is less than prior years. Eliminating some large run times with no rainfall, indicates flows increased with rainfall (solid line). Note station leaks at high tides. - Lift Station 3 Service Area

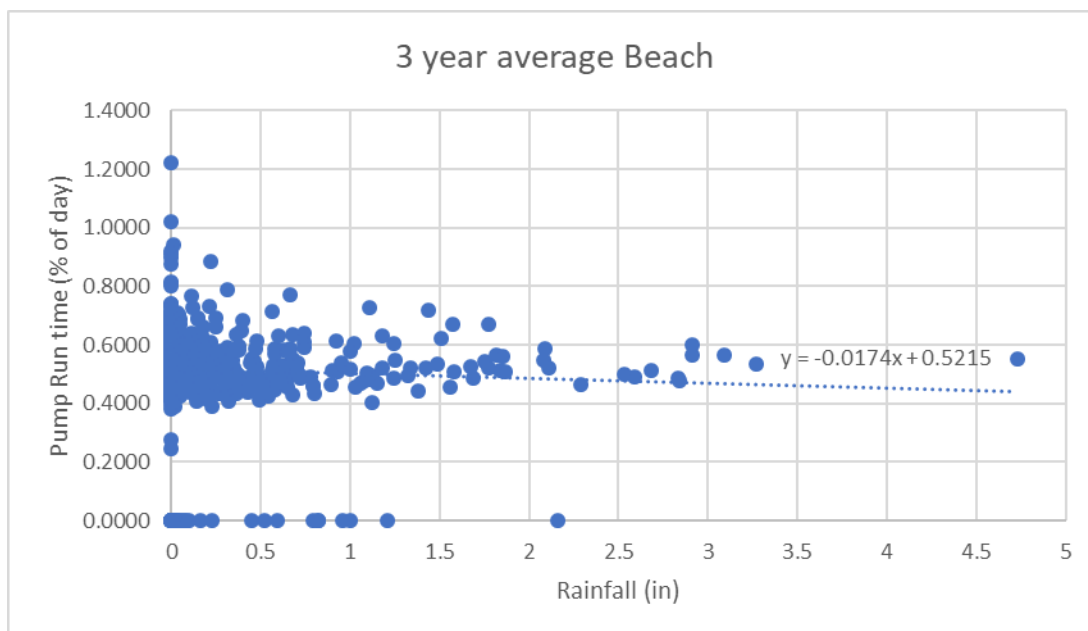
Figure 3.16– Average graphic foe Inflow for 2014-2017 – the increasing slope indicates flows increased with rainfall - Lift Station 3 Service Area

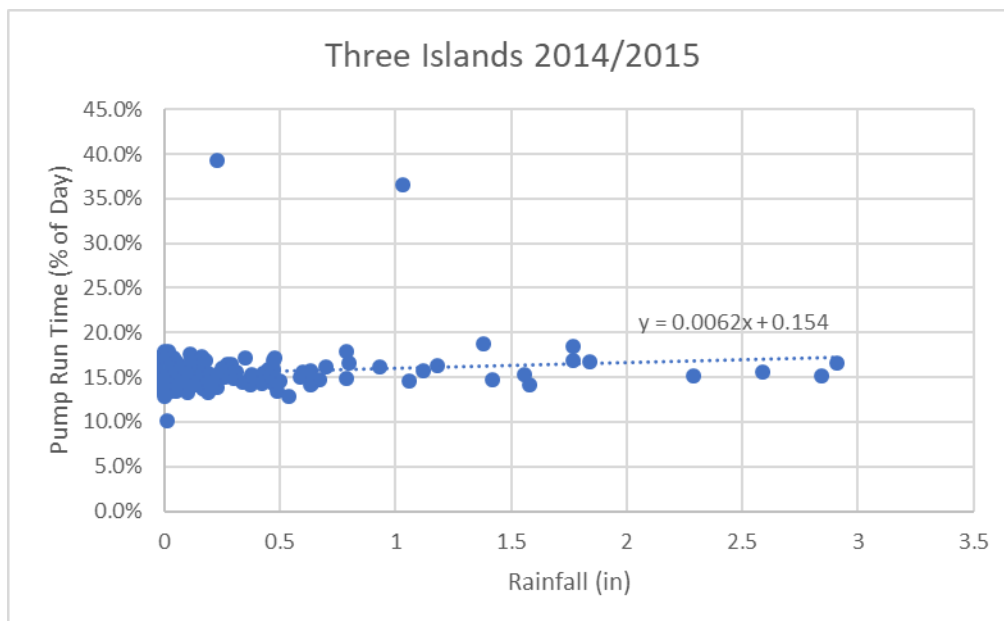
There was one site that smoke testing indicated was open to the surface. The only opening was across from 930 NE 27th Ave. The property owners should be advised of the issue and required to make appropriate corrections. The midnight run showed that most of the piping in this service area needed to be televised.

Figure 3.18 – Inflow for 2014-2015 – the increasing slope indicates flows increased with rainfall - Lift Station 4 Service Area

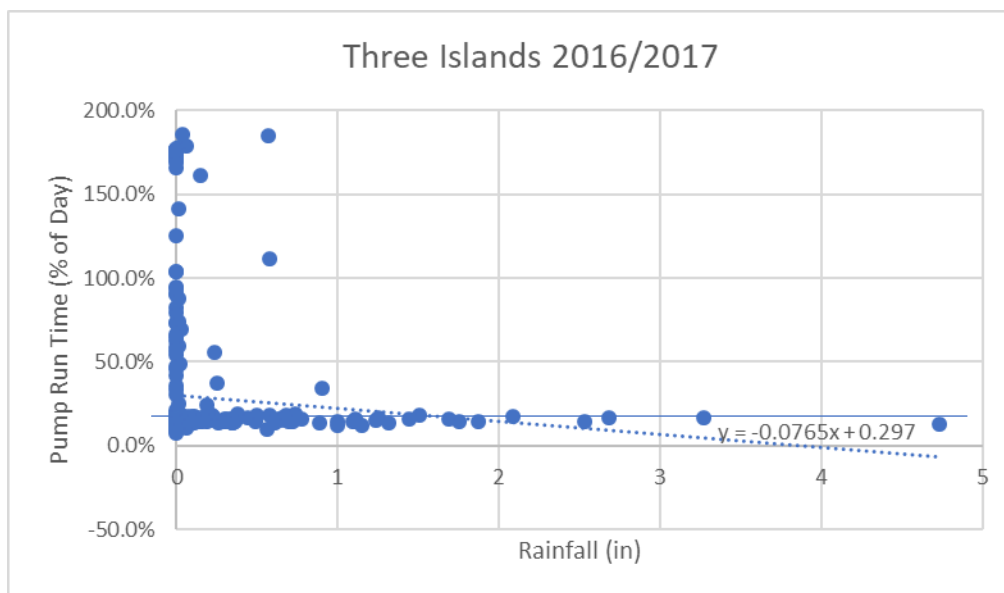
Figure 3.20 – Inflow for 2016-2017 – the regression slope is negative, but note some early high run times. The actual slope (solid line) slope indicates flows increased with rainfall - Lift Station 4 Service Area

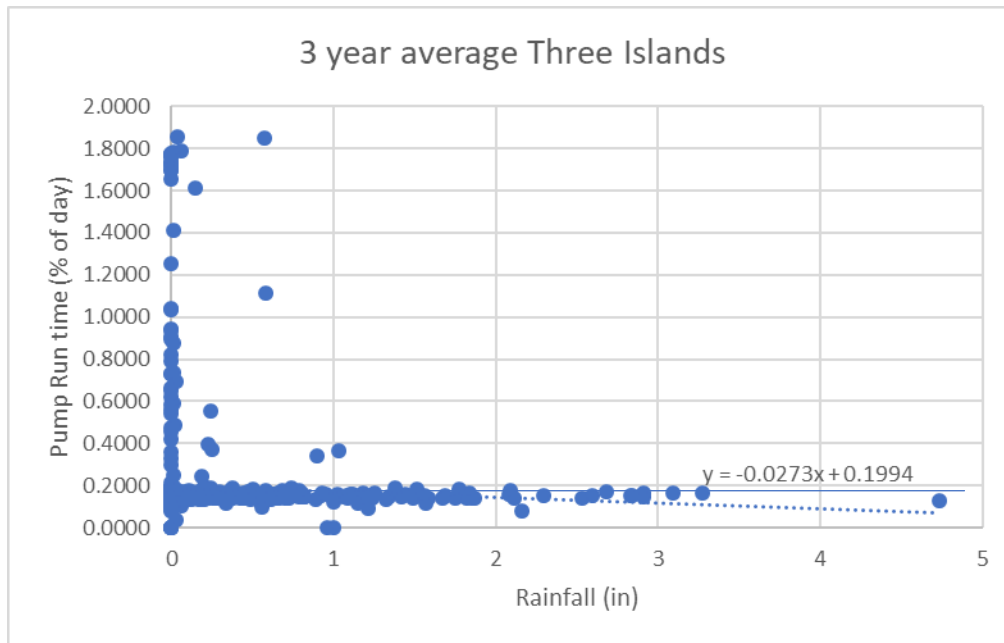
Figure 3.21 – Average graphic for Inflow for 2014-2017 – the slope indicates the system is fairly tight. - Lift Station 4 Service Area

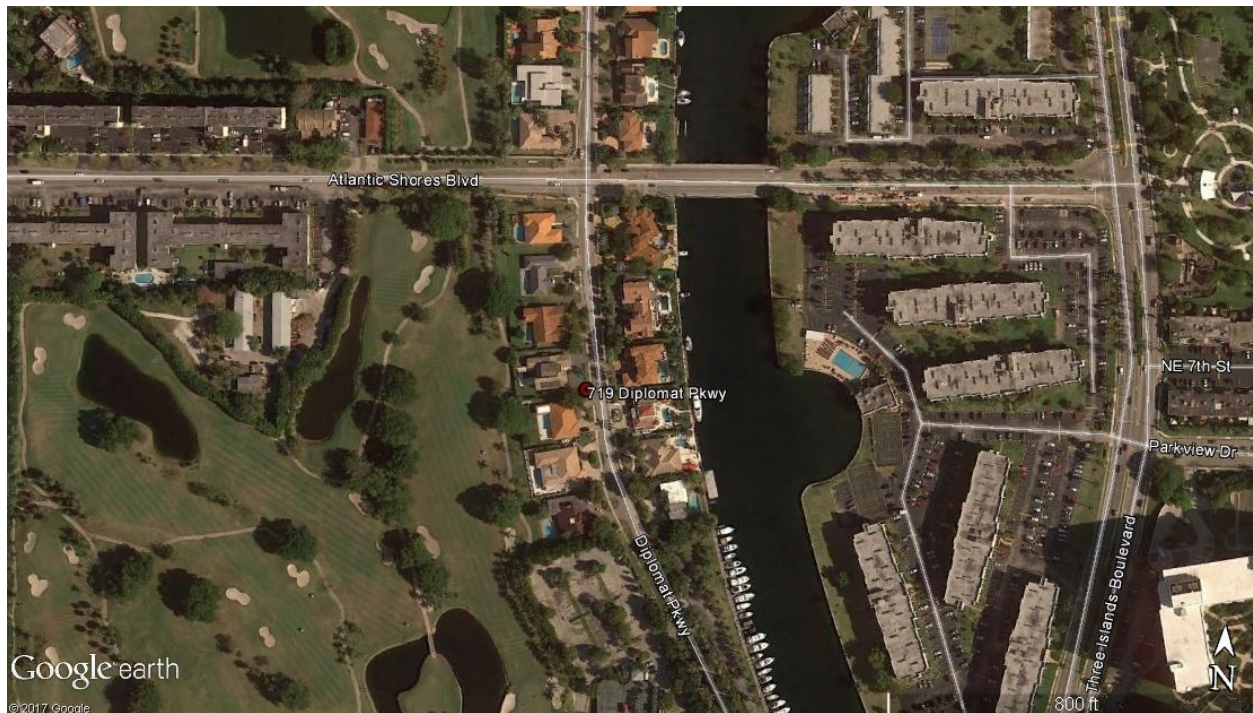
Figure 3.28 Location of Smoke test leaks - Lift Station 5 Service Area

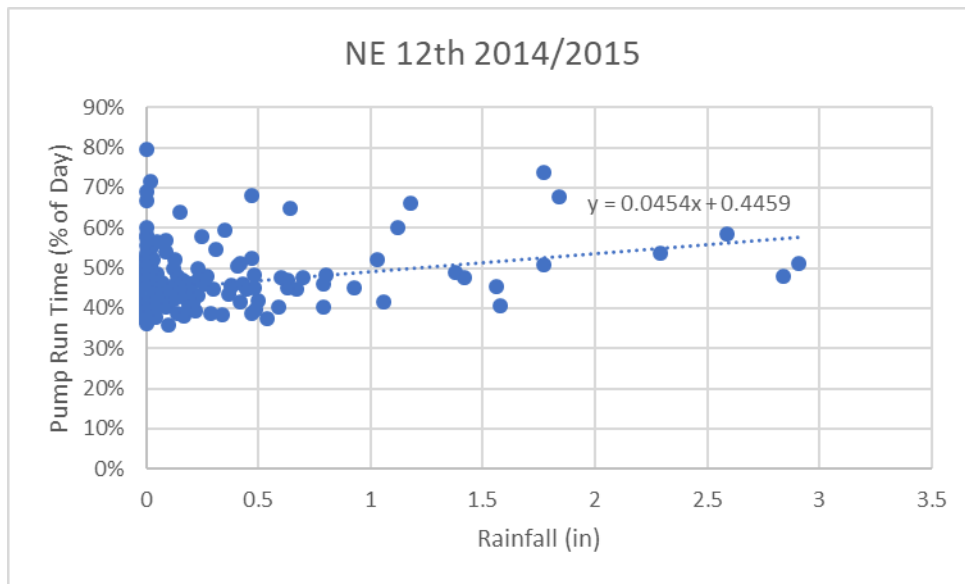
The midnight run indicated many issues throughout the area. The condos along NE 12th Ave all contribute major flows after 1:00 am for no apparent reason. Lights were off. These private systems need to be televised under the City's ordinance prohibiting excessive inflow and infiltration into the system. They are major contributors of water. Much of the area was lined previously, especially the north end. The liners were noted to be leaking and flows existed – probably indicating service line leaks. Half the pipe in this service areas needs to be reviewed. A lot of grease, sand, debris, mineral and even jewelry was found in manholes in the is service area.

Figure 3.29– Inflow for 2014-2015 – the increasing slope indicates flows increased with rainfall
- Lift Station 6 Service Area

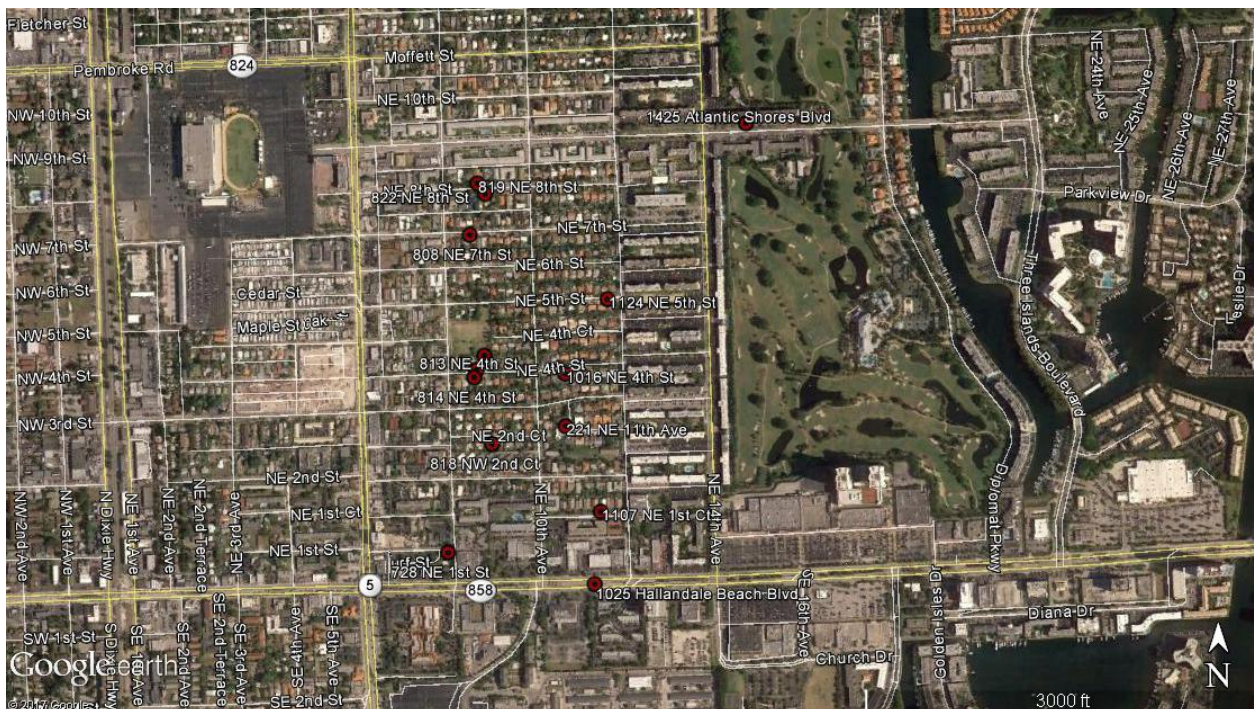
Figure 3.34 Location of Smoke test leaks - Lift Station 6 Service Area

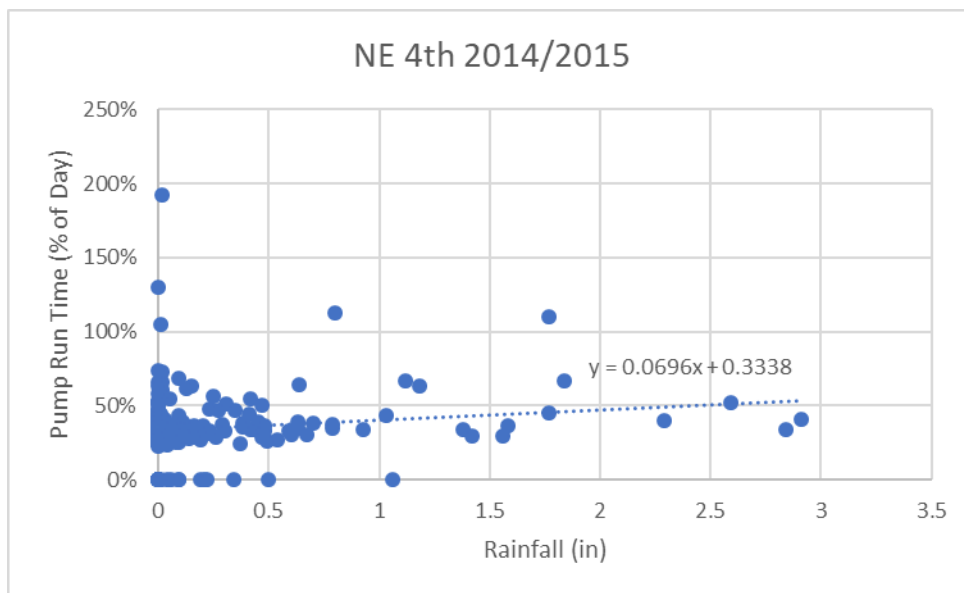
The midnight run in this service area indicated leakage around the dog track despite being after hours. Cedar St., Maple St, NE 2nd Ave and NE 1st Ave were other significant areas of concern.

Figure 3.35 – Inflow for 2014-2015 – the increasing slope indicates flows increased with rainfall
- Lift Station 7 Service Area

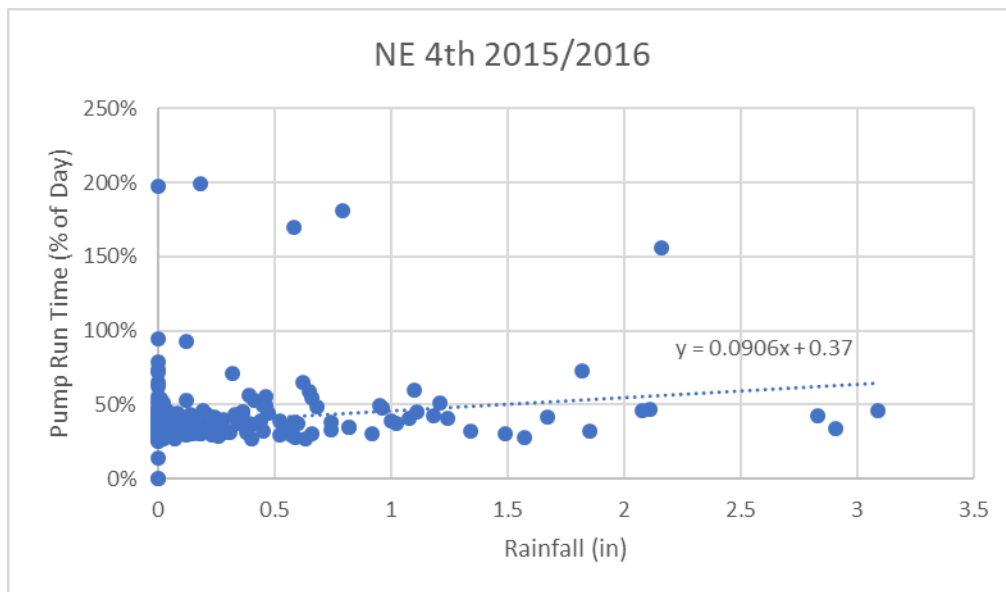
Figure 3.36 – Inflow for 2015-2016 – the increasing slope indicates flows increased with rainfall - Lift Station 7 Service Area

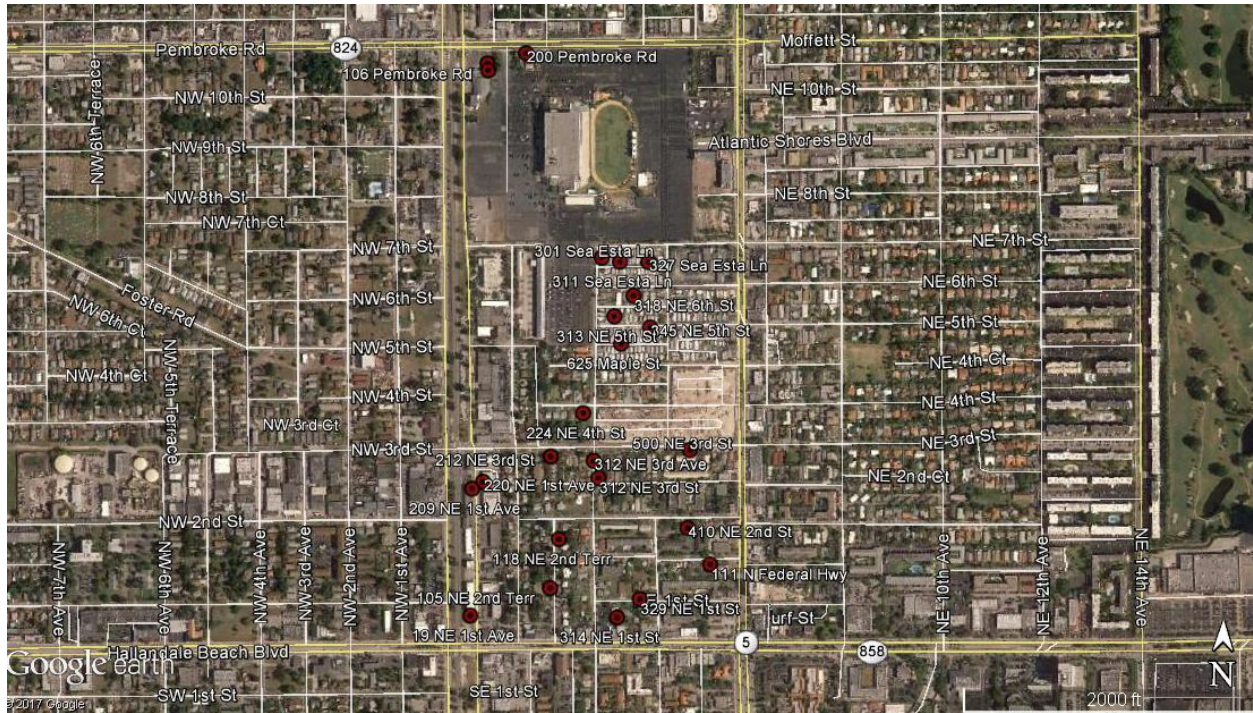
Figure 3.40 Location of Smoke test leaks - Lift Station 7 Service Area

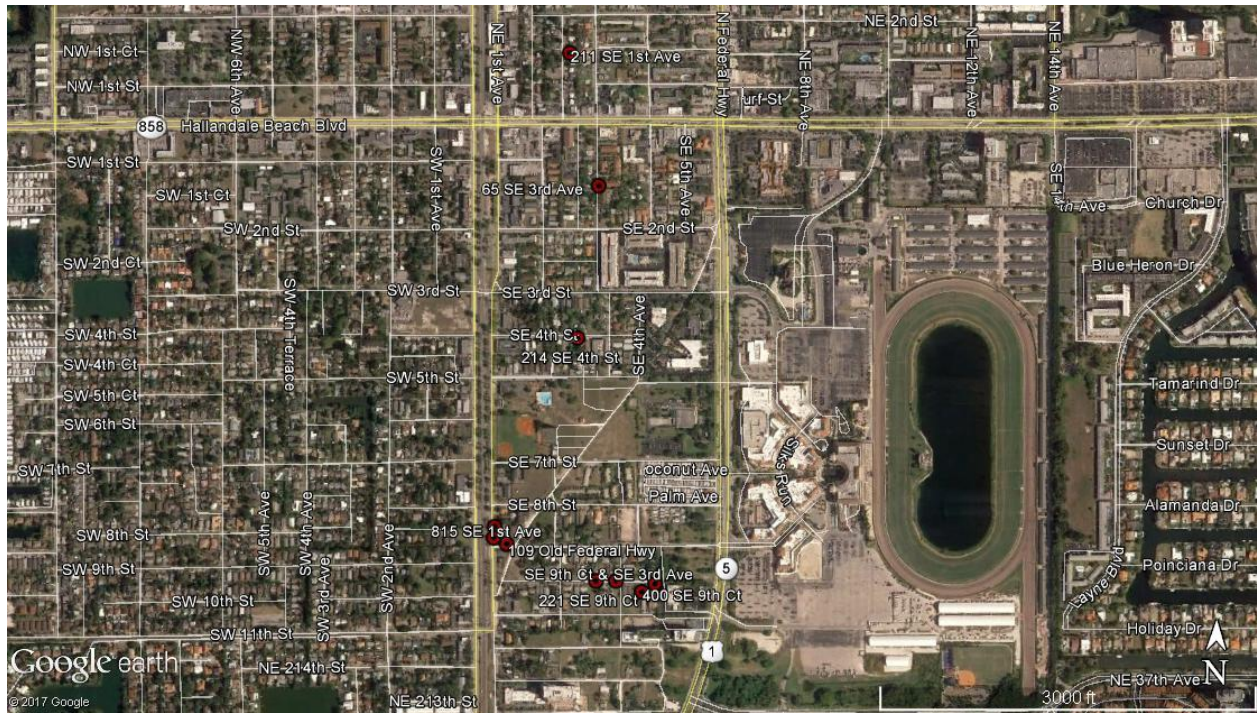
Figure 3.46 Location of Smoke test leaks - Lift Station 8 Service Area

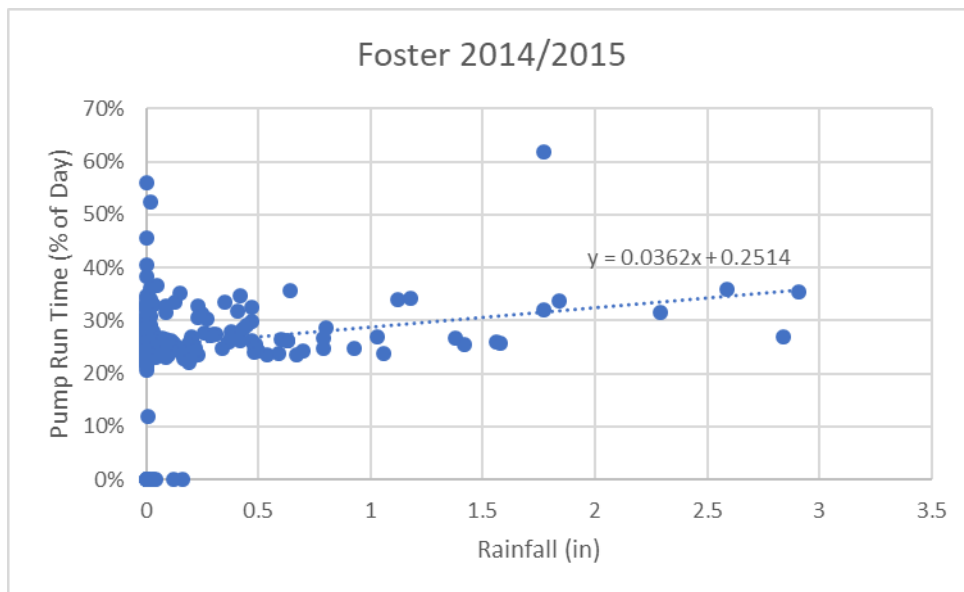
Service area 9 was an area with a lot of both inflow and infiltration. Many shallow lines showed flow during the midnight run. These dead ends largely should not have flowed. The area east of the cemetery was particularly poor. Areas under Pembroke Road showed flows – some were not accessible due to traffic. The high school has two lines discharging large flows (half full pipe) at 3:00 am. In Manholes #09-10 and 09-011. That needs further investigation. The water was clear. Overall this area showed significant leakage after hours. A commercial laundry was noted (leaked sheets into the City's system (since corrected).

Figure 3.47 – Inflow for 2014-2015 – the increasing slope indicates flows increased with rainfall
- Lift Station 9 Service Area

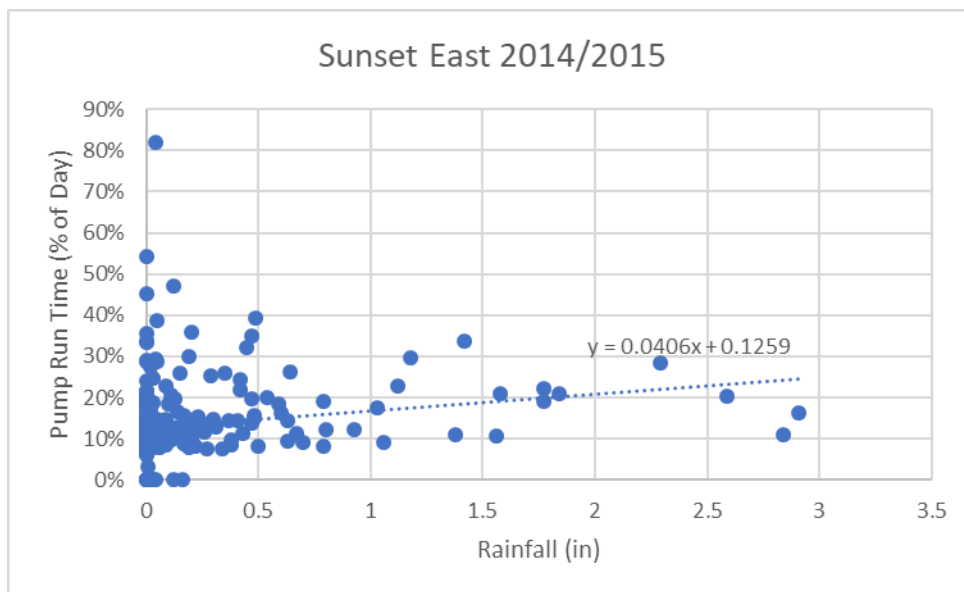
The midnight run showed that only the piping on North Palm Dr. needed to be televised. However, there were heavy mineral deposits on the walls in Manhole 10-003 indicating it many need to be sealed.

Figure 3.53 – Inflow for 2014-2015 – the increasing slope indicates flows increased with rainfall - Lift Station 10 Service Area

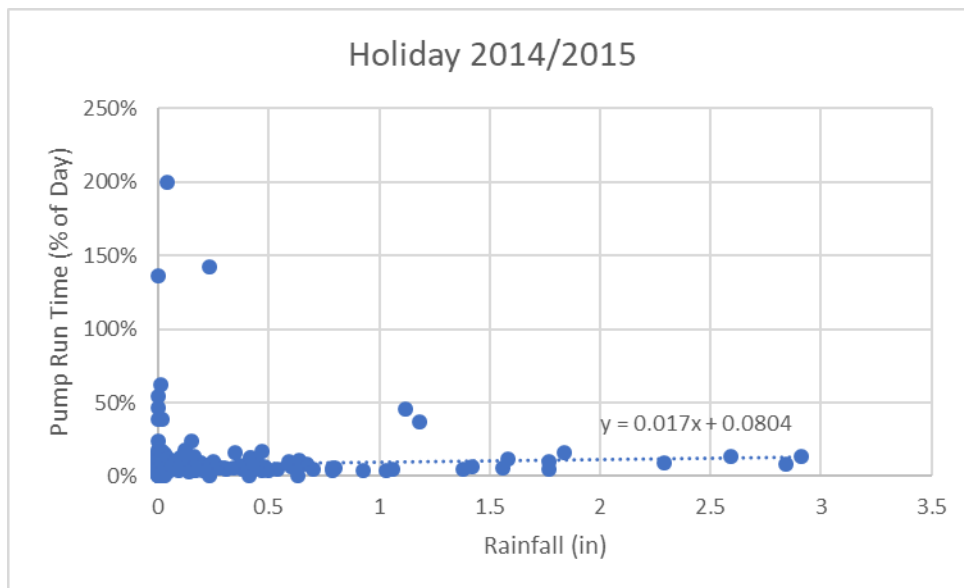
The midnight run showed that all of the piping in this service area along Holiday Drive needed to be televised. Major flow entered between Manholes 11-003 and 11-004. Note the area is on an island and saltwater can enter during high tides.

Figure 3.63 - Inflow for 2014-2015 – the increasing slope indicates flows increased with rainfall
- Lift Station 11 Service Area

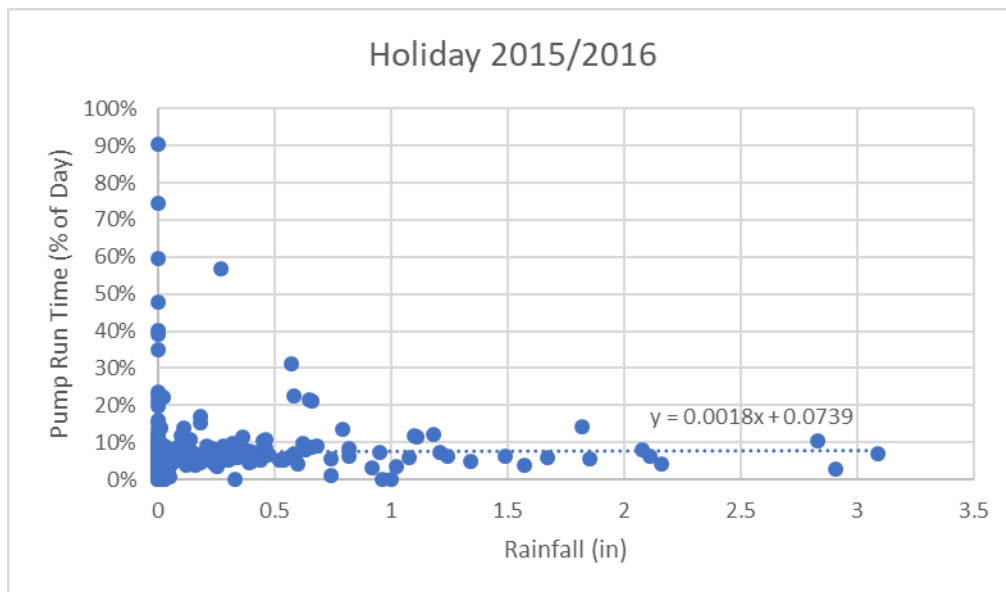
Figure 3.64 – Inflow for 2015-2016 – the increasing slope indicates flows increased with rainfall - Lift Station 11 Service Area

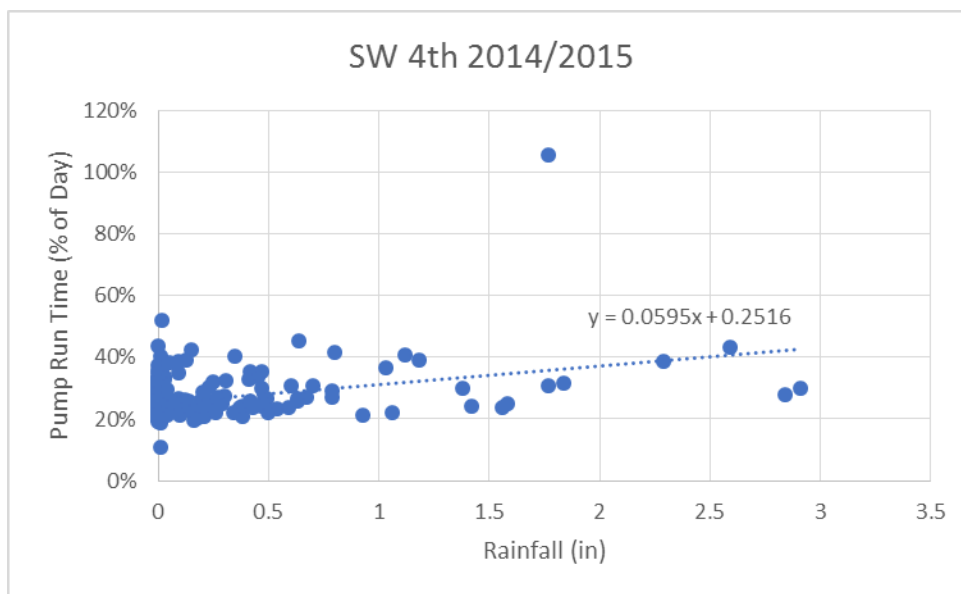
Figure 3.68 – Inflow for 2014-2015 – the increasing slope indicates flows increased with rainfall - Lift Station 12 Service Area

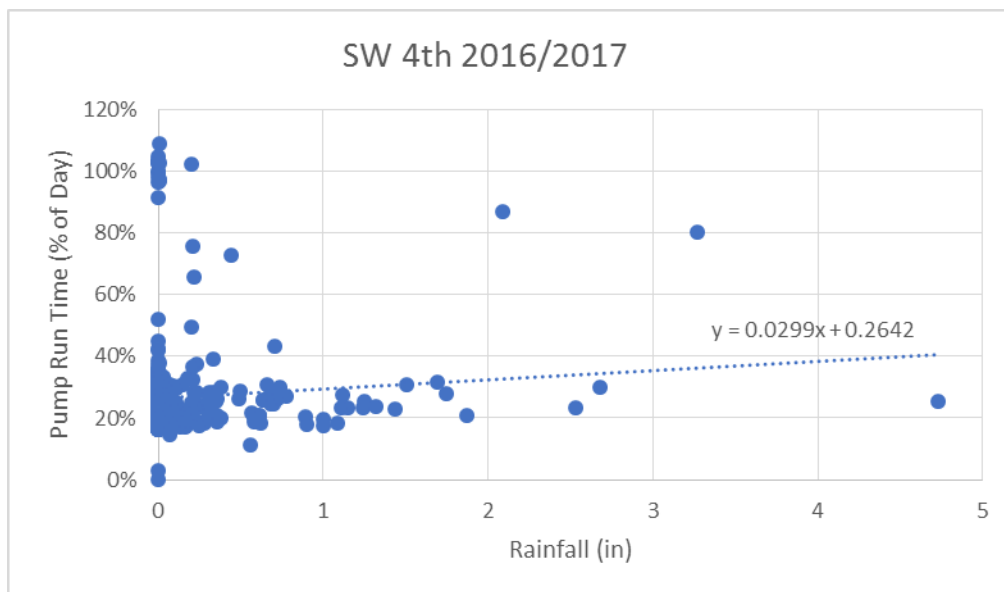
Figure 3.70 – Inflow for 2016-2017 – the regression slope is negative, but note some early high run times. The actual slope (solid line) slope indicates flows increased with rainfall - Lift Station 12 Service Area
