SSES PHASE I

CITY OF HALLANDALE BEACH, FLORIDA

FY 2018

DEP Clean Water SRF Project No. ***

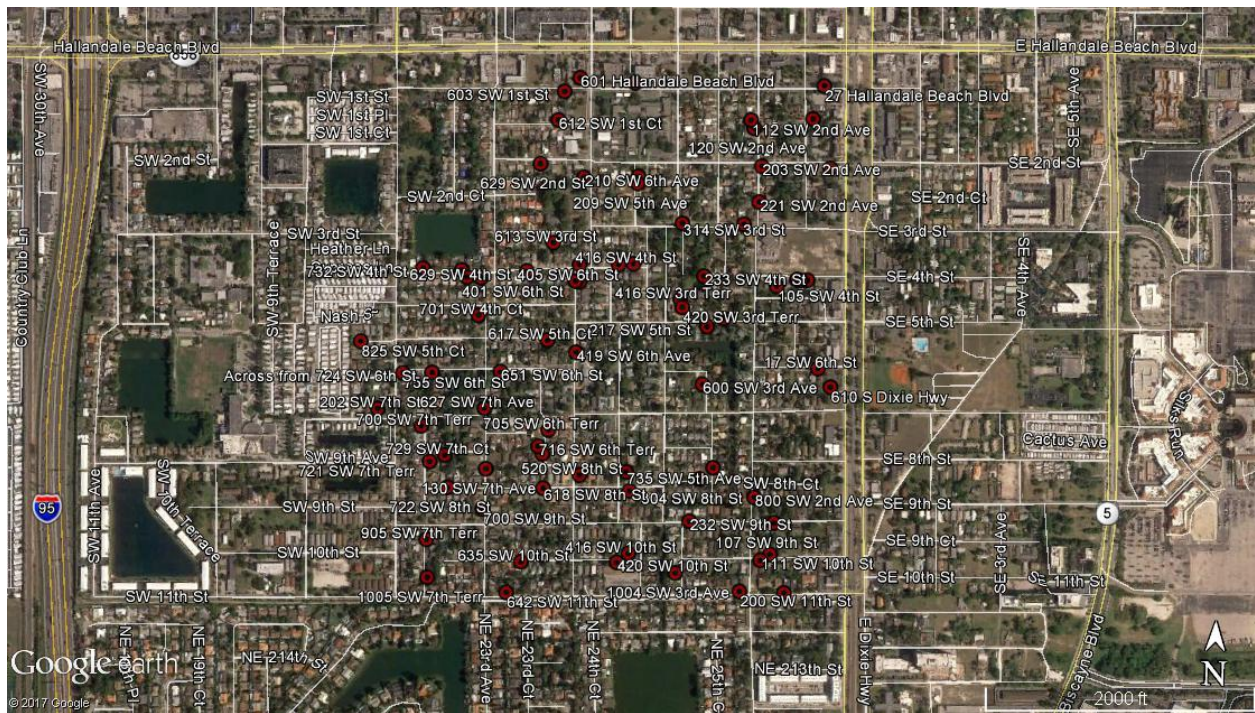
Figure 3.73 Location of Smoke test leaks - Lift Station 12 Service Area

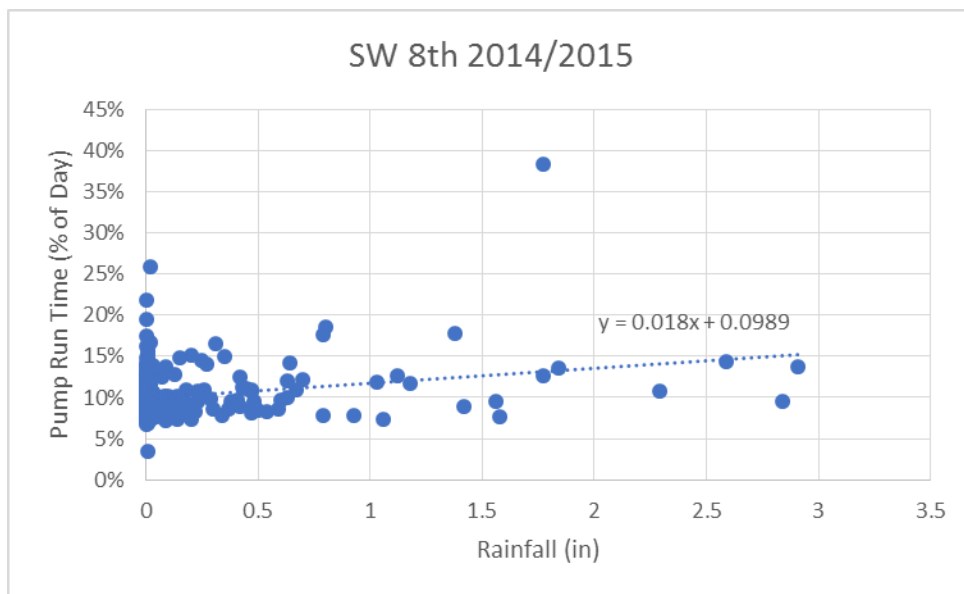
Figure 3.74 – Inflow for 2014-2015 – the increasing slope indicates flows increased with rainfall
- Lift Station 13 Service Area

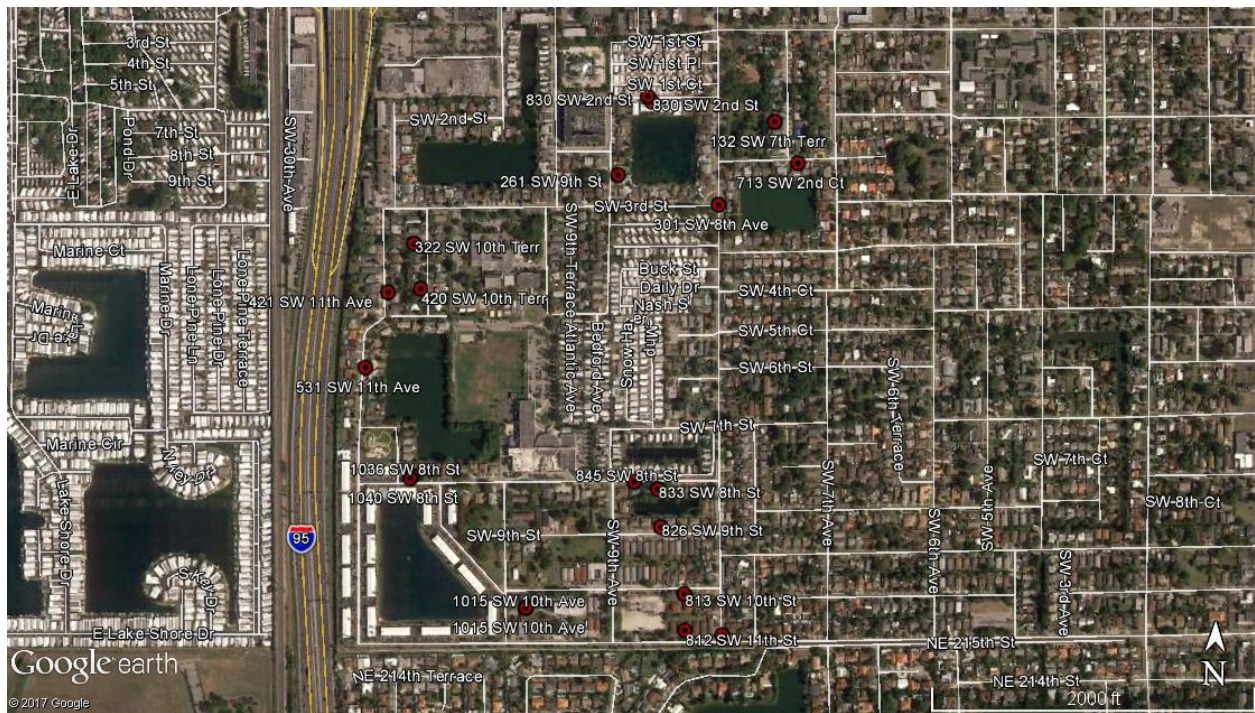
Figure 3.79 - Location of Smoke test leaks - Lift Station 12 Service Area

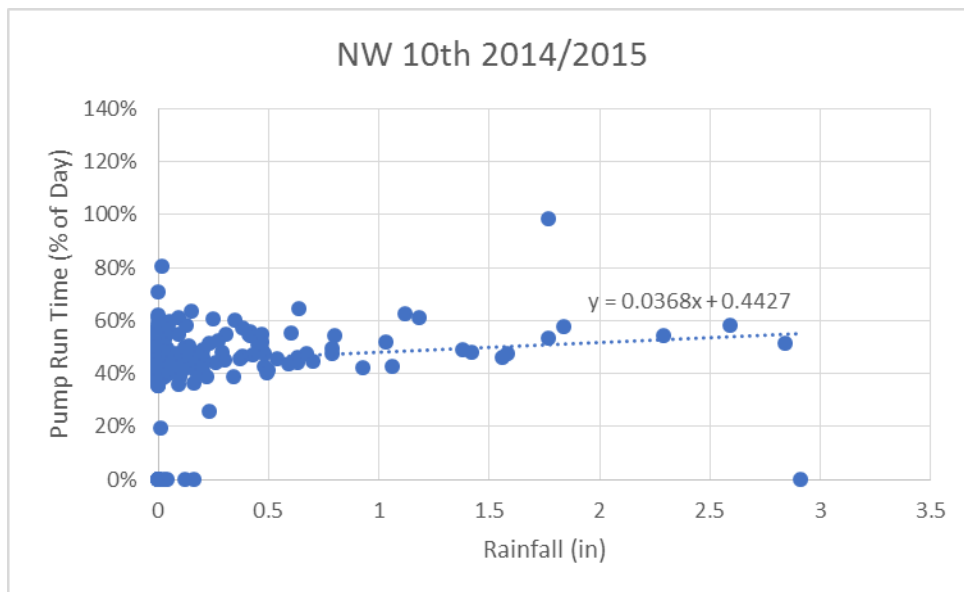
Figure 3.80 – Inflow for 2014-2015 – the increasing slope indicates flows increased with rainfall
- Lift Station 14 Service Area

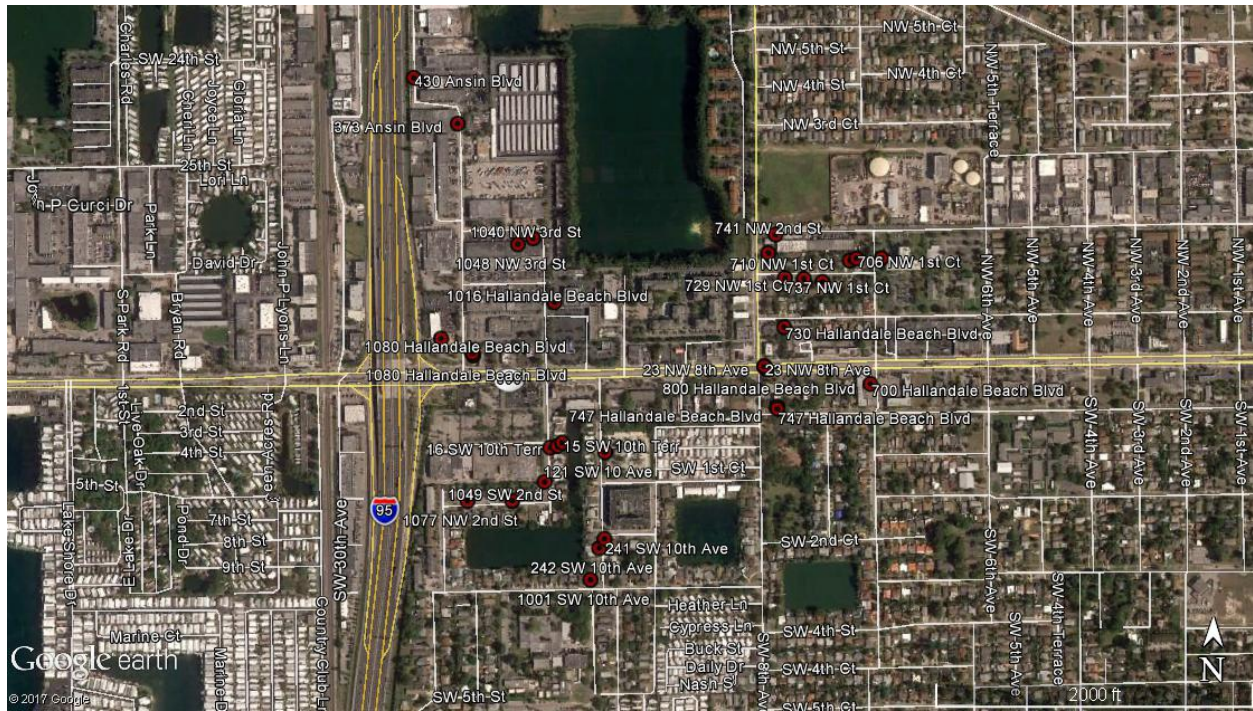
Figure 3.85 - Location of Smoke test leaks - Lift Station 14 Service Area

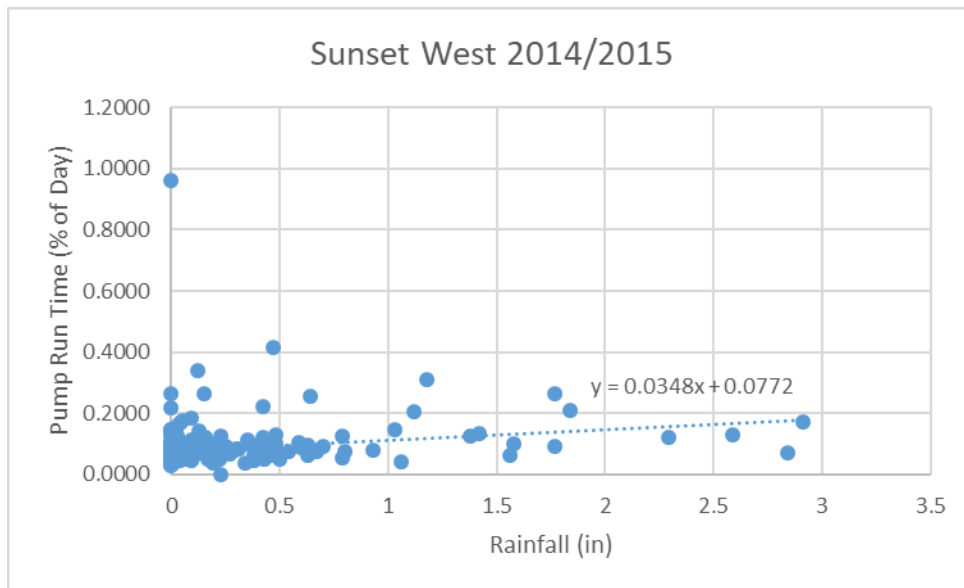
Figure 3.86 – Inflow for 2014-2015 – the increasing slope indicates flows increased with rainfall - Lift Station 15 Service Area

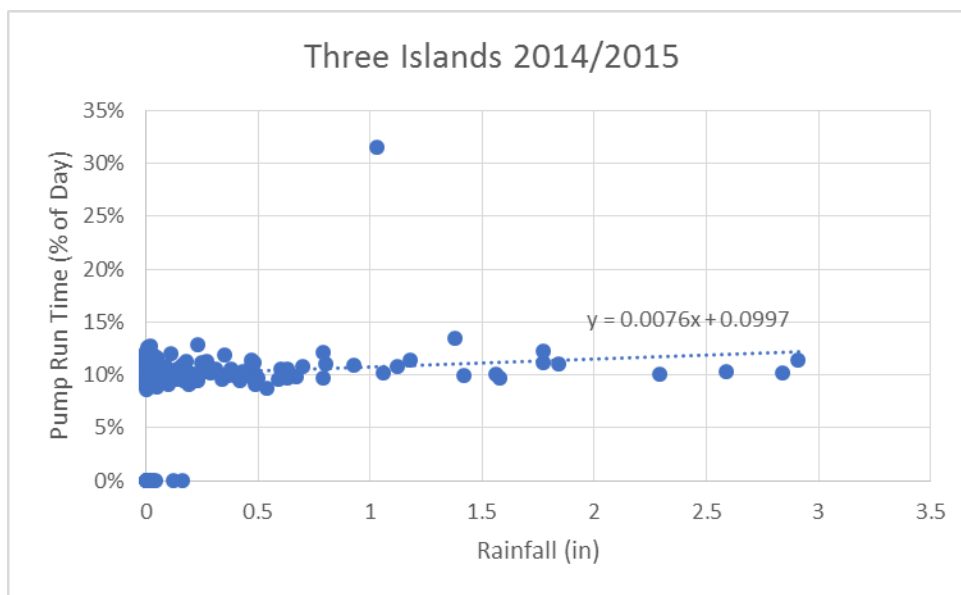
Figure 3.90 – Inflow for 2014-2015 – the increasing slope indicates flows increased with rainfall
- Lift Station 18 Service Area
