## SSSES PHASE I

## CITY OF HALLANDALE BEACH, FLORIDA

FY 2018

DEP Clean Water SRF Project No. \*\*\*

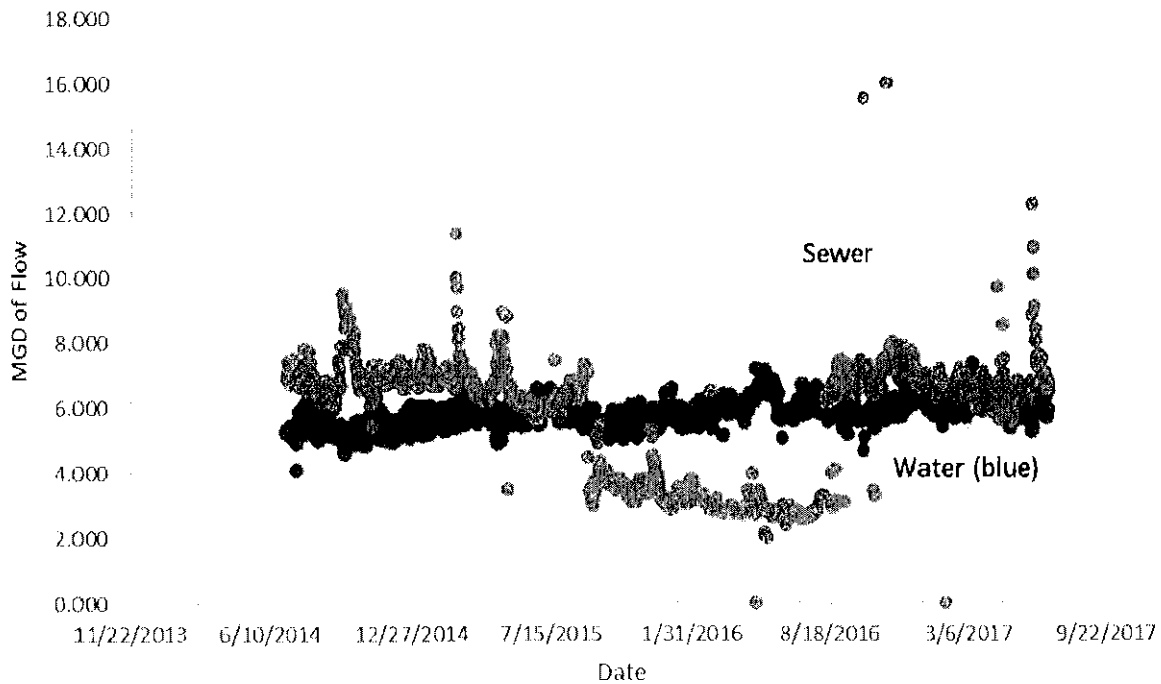
Figure 1.6 Water and Wastewater Flow comparison, 2014-2017 - note largest meter out of service in 2015/16

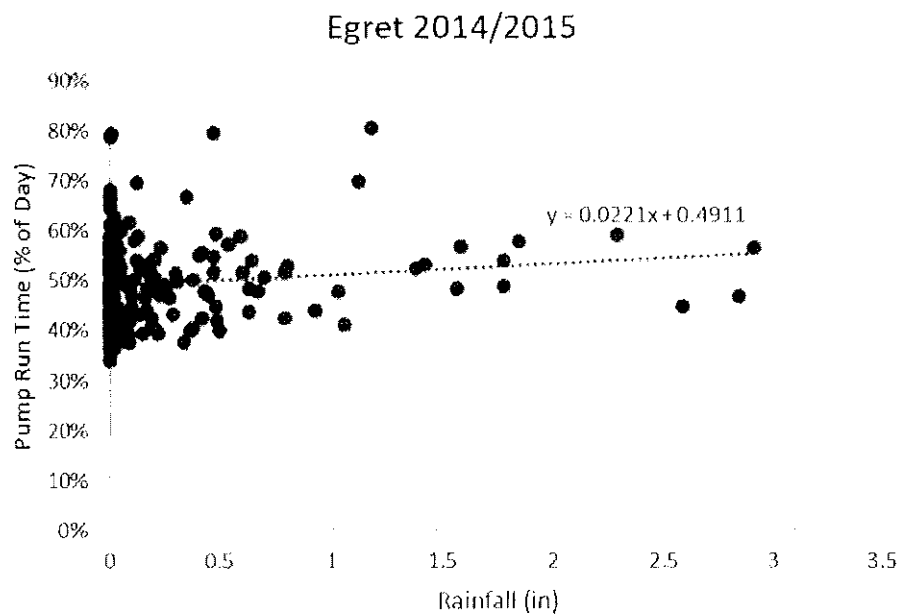
Figure 3.1 – Inflow for 2014-2015 – the increasing slope indicates flows increased with rainfall

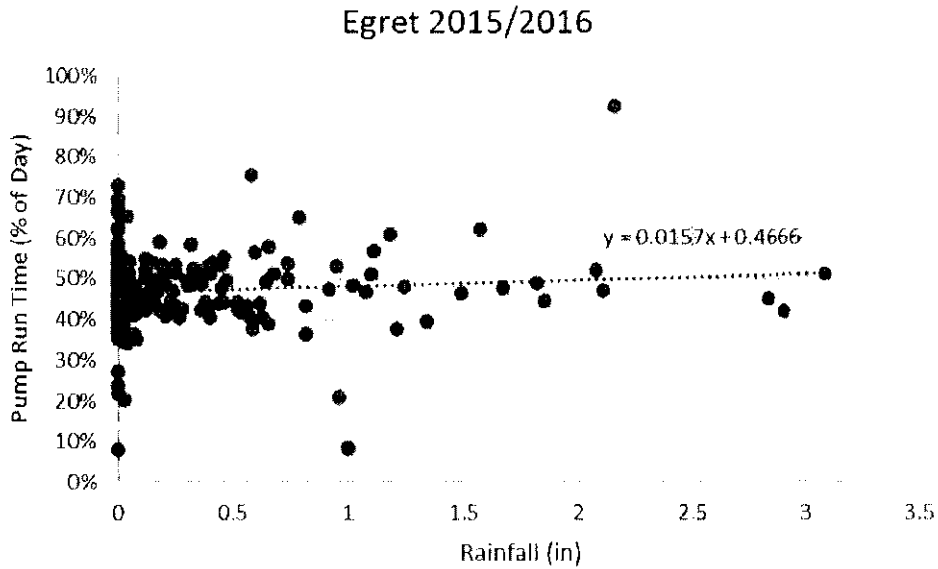
Figure 3.2 – Inflow for 2015-2016 – the increasing slope indicates flows increased with rainfall - Lift Station 1 Service Area

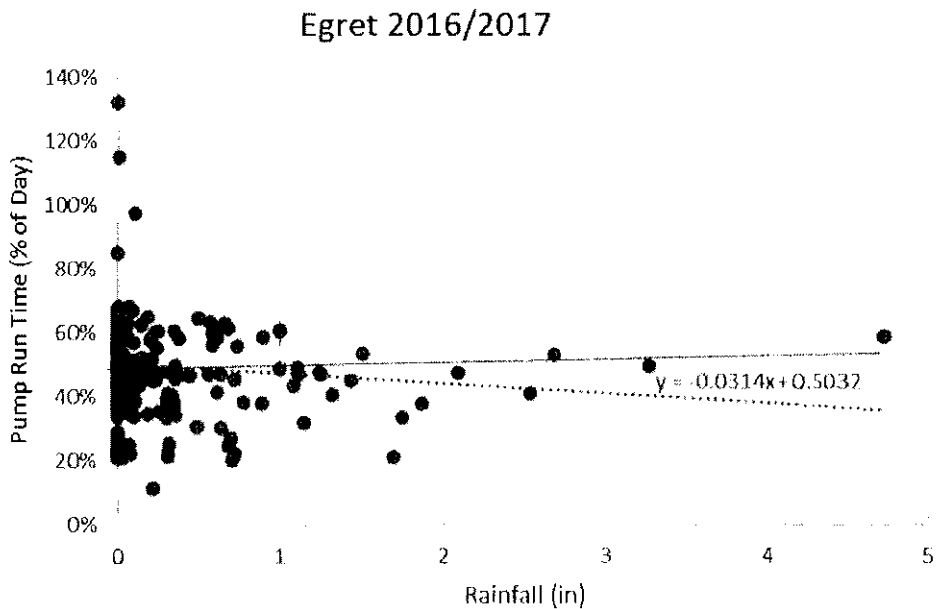
Figure 3.3 – Inflow for 2016-2017 – the regression slope is negative, but note some early high run times. The actual slope (solid line) slope indicates flows increased with rainfall- Lift Station 1 Service Area

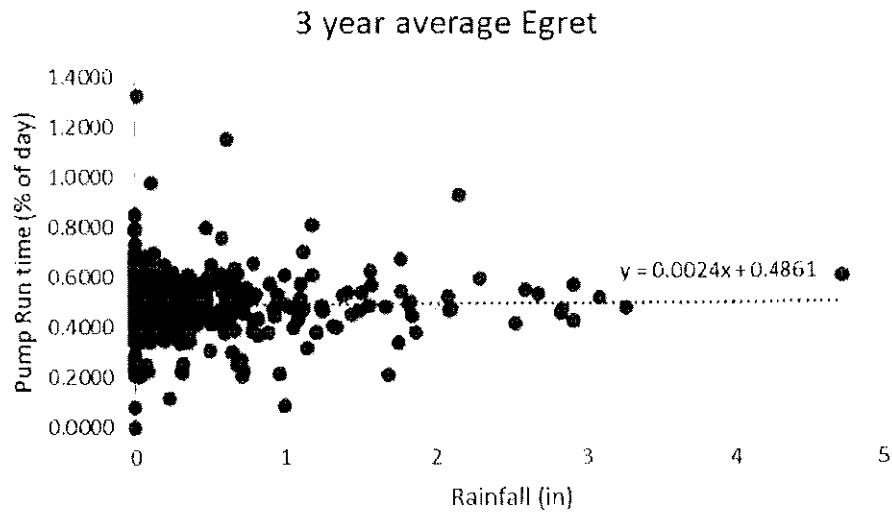
The Lift Station 1 service area contains 51 manholes that were found, GPSed and sealed. The midnight run indicated points where infiltration as noted (see map in Appendix A). A review of rainfall versus flows from July 1, 2014 to June 30, 2016 indicates that the slope of the line is decreasing, indicating inflow volumes were being controlled (see Figures 3.1 and 3.2). The slope went in 2017 which required further investigation (see Figure 3.3). It appears some very large pump run time (check valve issues) at periods with no rain may have skewed this line. However, there were few openings found on the system so perhaps inflow has been controlled to an extent. The overall trend indicates inflow is present (see Figure 3.4). The average pumps times increased from 2014 to 2017 (to 50.3%).

Figure 3.4 – Average graphic for Inflow for 2014-2017 – the increasing slope indicates flows increased with rainfall - Lift Station 1 Service Area

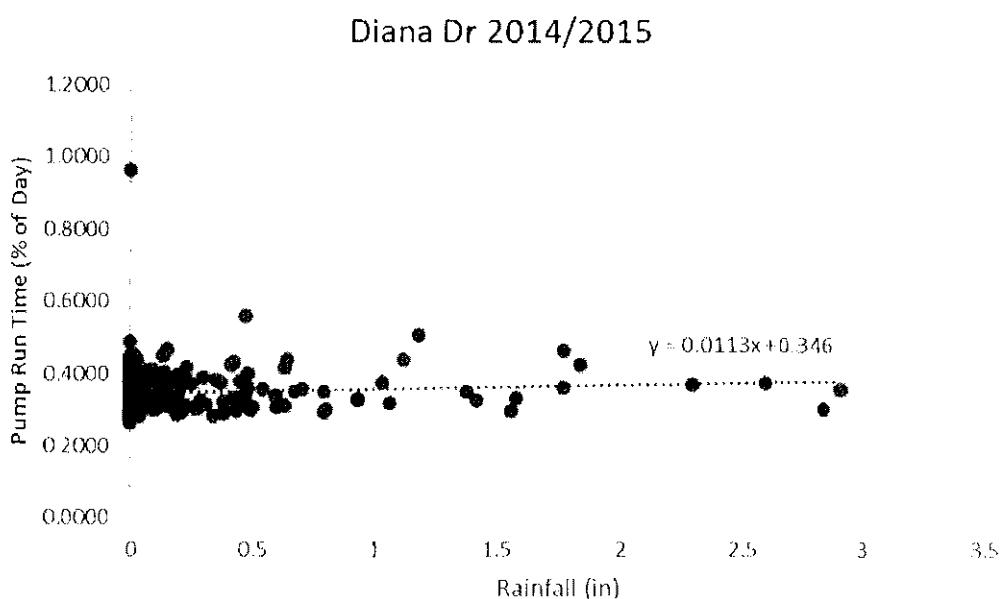
Figure 3.7 – Inflow for 2014-2015 – the increasing slope indicates flows increased with rainfall

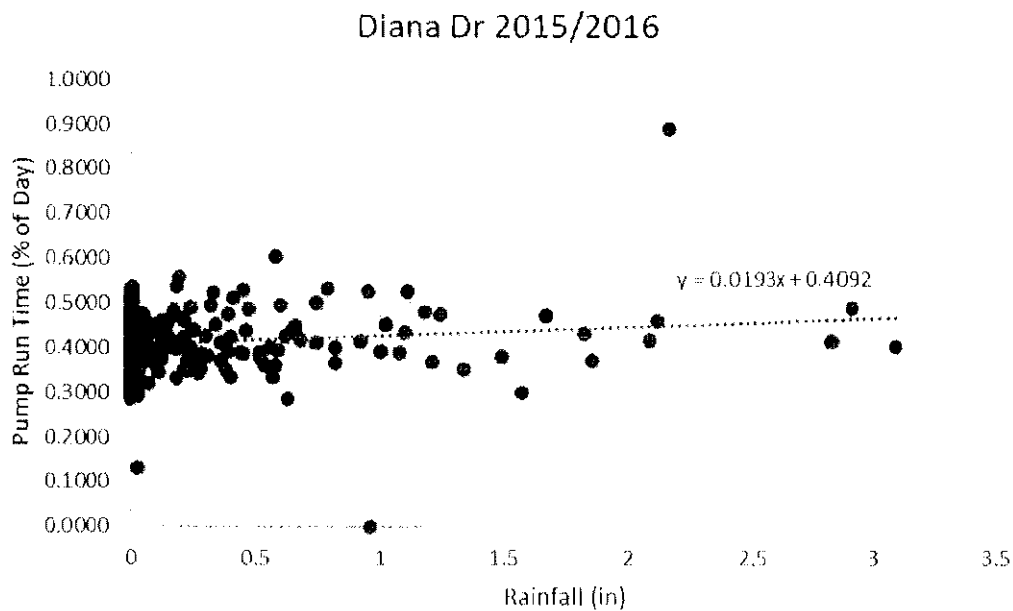
Figure 3.8 – Inflow for 2015-2016 – the increasing slope indicates flows increased with rainfall - Lift Station 2 Service Area

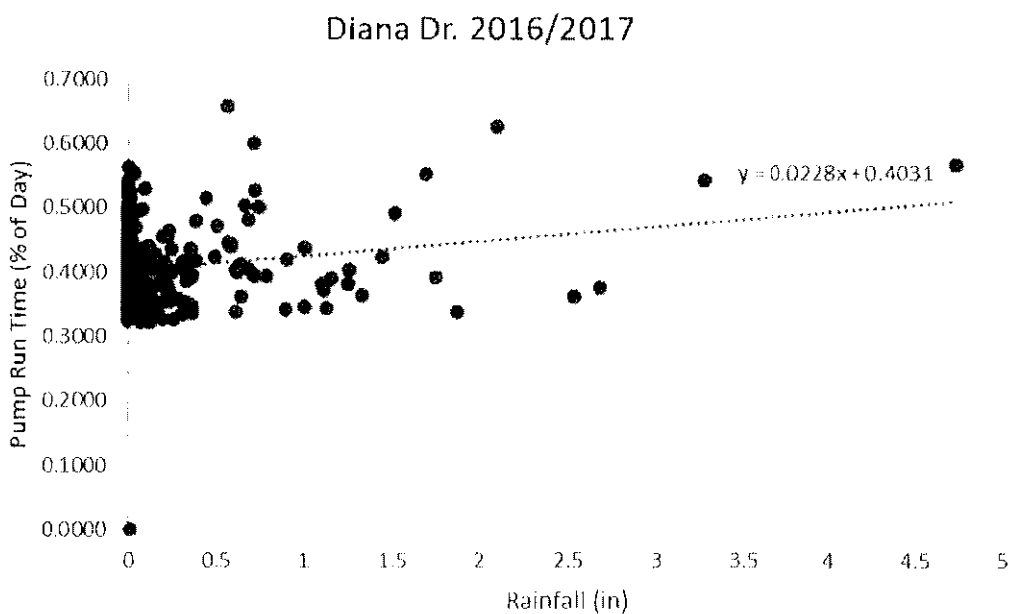
Figure 3.9 – Inflow for 2016-2017 – the regression slope is negative but note some early high run times. The actual slope (solid line) slope indicates flows increased with rainfall - Lift Station 2 Service Area

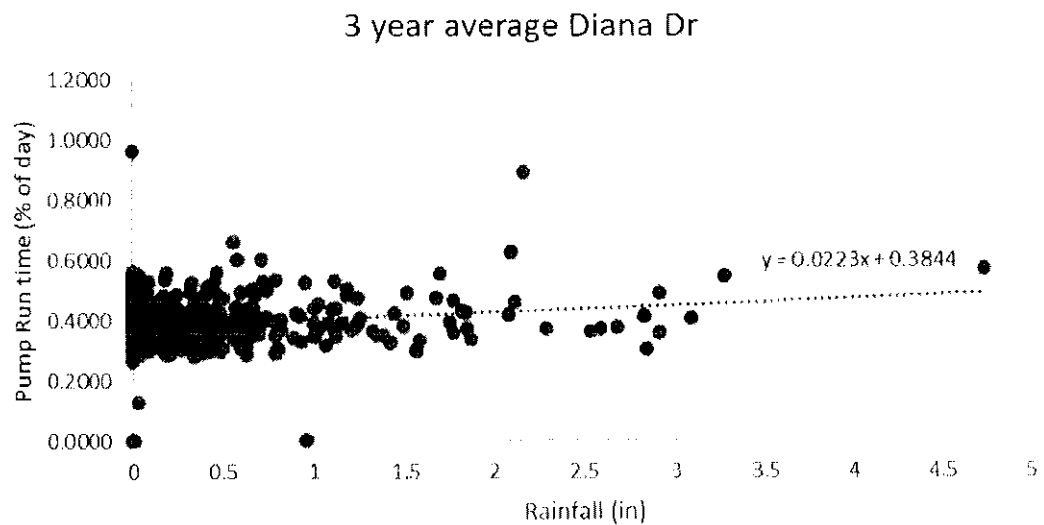
Lift Station 2 service area contains 38 manholes that were found, GPSed and sealed. The midnight run indicated points where infiltration as noted (see map in Appendix A). A review of rainfall versus flows from July 1, 2014 to June 30, 2017 indicates that the slope of the line is increasing, indicating inflow volumes were increasing (see Figures 3.7 to 3.9). There were eight openings found on the system. The overall trend indicates inflow is present (see Figure 3.10). The average pumps times increased from 2014 to 2017 (to about 40%).

Figure 3.10 – Average graphic for Inflow for 2014-2017 – the increasing slope indicates flows increased with rainfall- Lift Station 2 Service Area

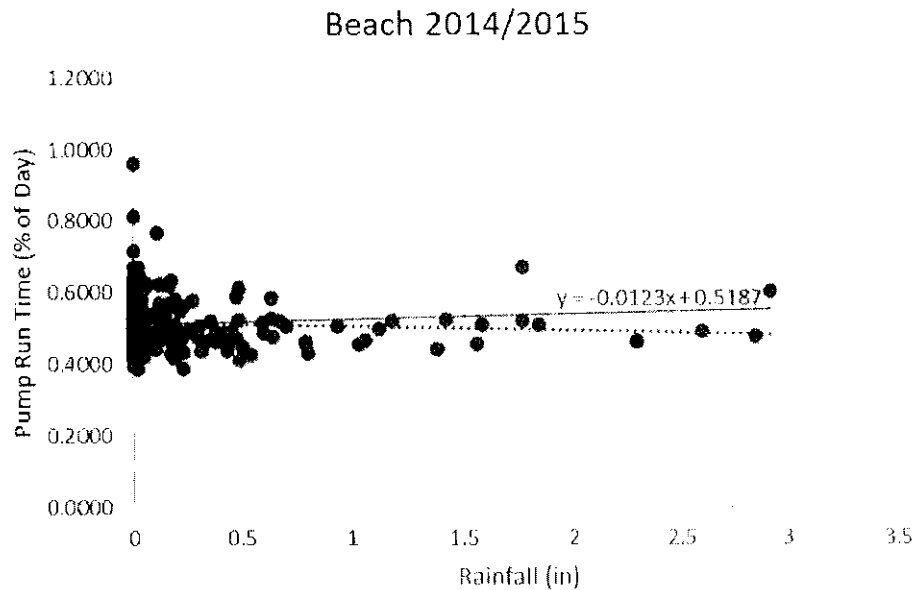
Figure 3.13-- Inflow for 2014-2015 – the decreasing regression slope requires further review. Eliminating some large run times with no rainfall, indicates flows increased with rainfall (solid line). Note station leaks at high tides - Lift Station 3 Service Area

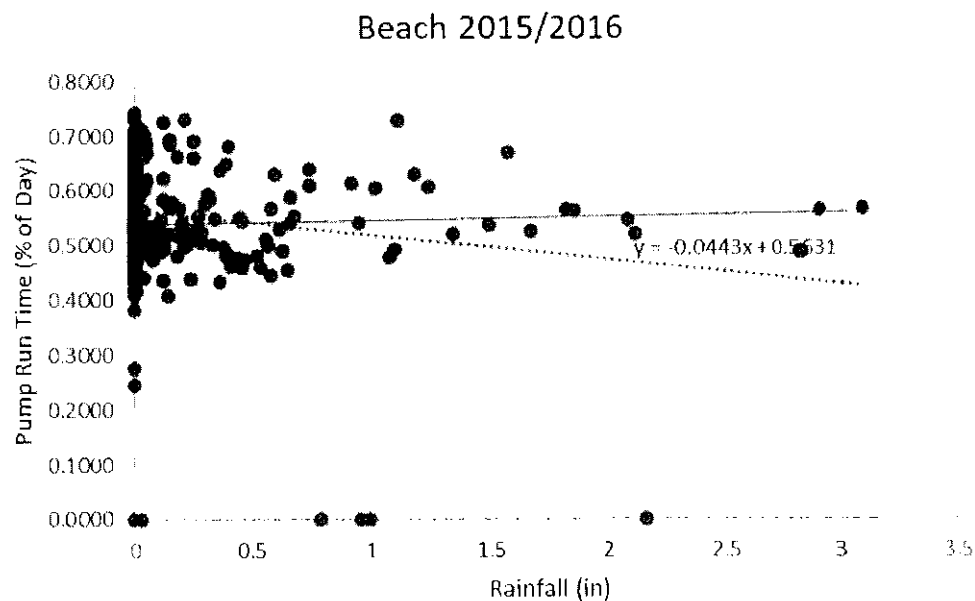
Figure 3.14 – Inflow for 2015-2016 – the decreasing regression slope requires further review. Eliminating some large run times with no rainfall, indicates flows increased with rainfall (solid line). Note station leaks at high tides. - Lift Station 3 Service Area

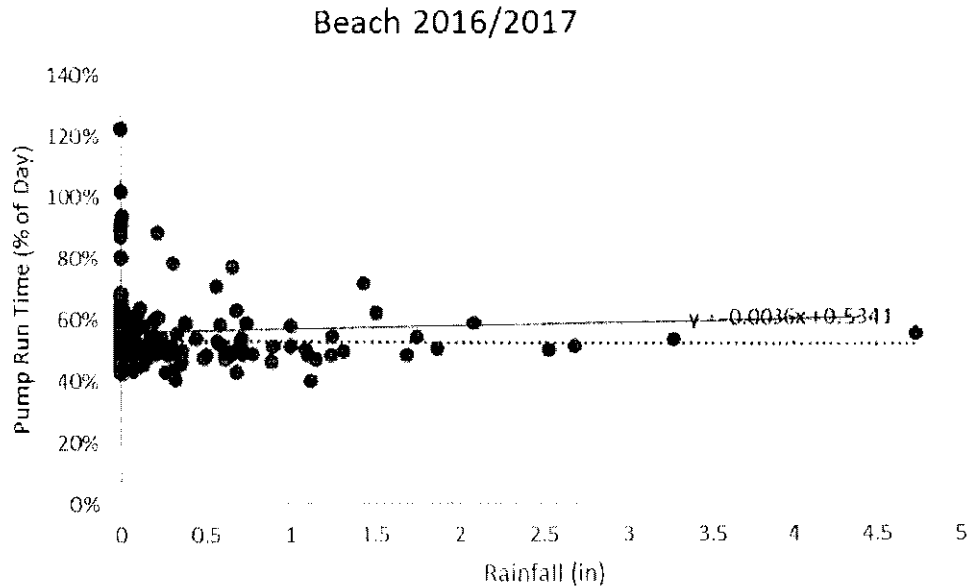
Figure 3.15 – Inflow for 2016-2017 – the slight decreasing regression slope requires further review. Note it is less than prior years. Eliminating some large run times with no rainfall, indicates flows increased with rainfall (solid line). Note station leaks at high tides. - Lift Station 3 Service Area

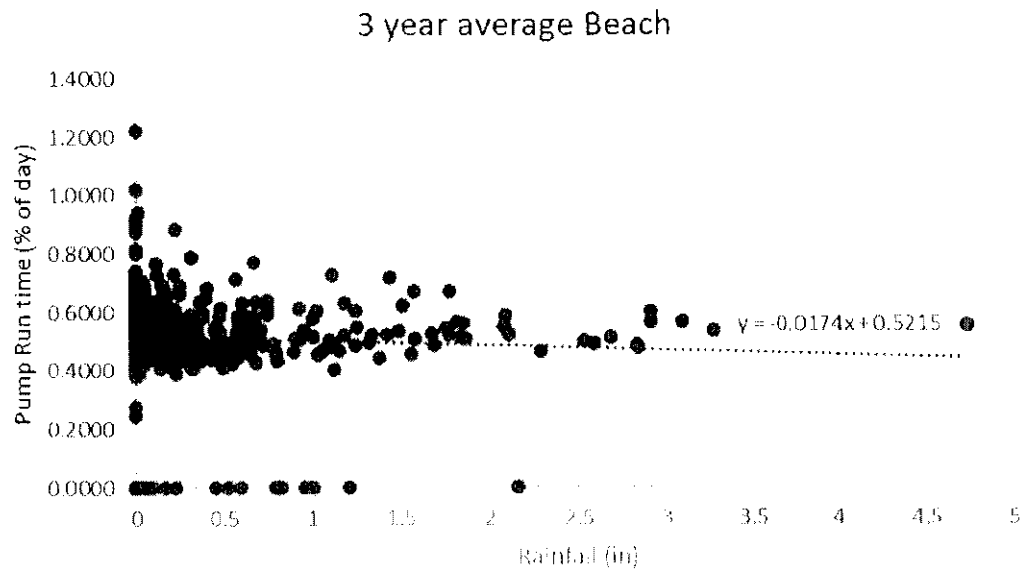
Figure 3.16– Average graphic foe Inflow for 2014-2017 – the increasing slope indicates flows increased with rainfall - Lift Station 3 Service Area

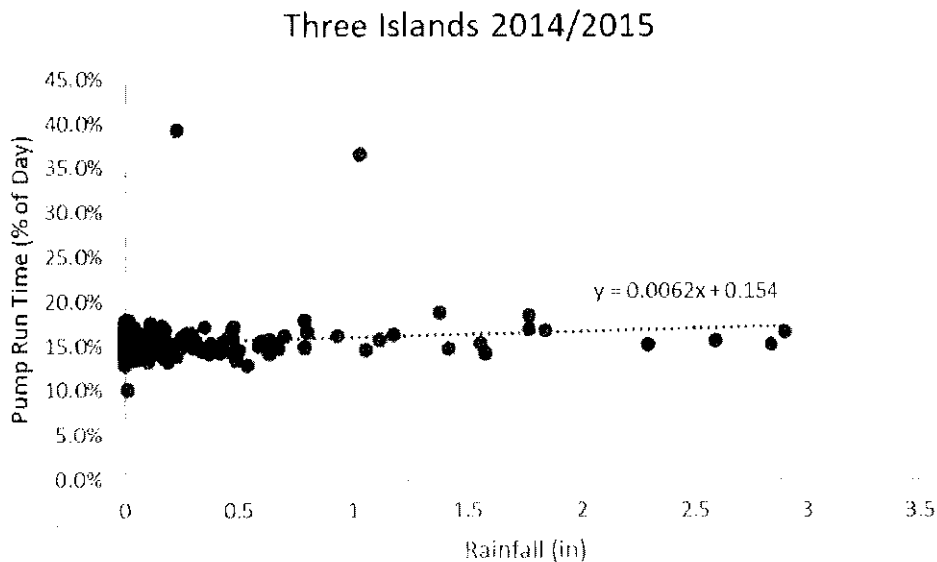
Figure 3.18 – Inflow for 2014-2015 – the increasing slope indicates flows increased with rainfall  
- Lift Station 4 Service Area

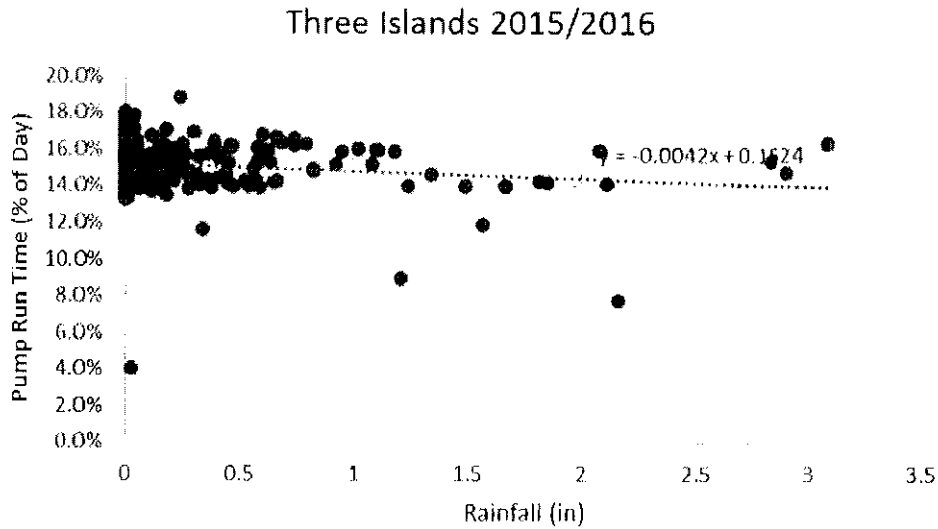
Figure 3.19– Inflow for 2015-2016 – The data is suspect as one of the pumps was not registering during the year. - Lift Station 4 Service Area

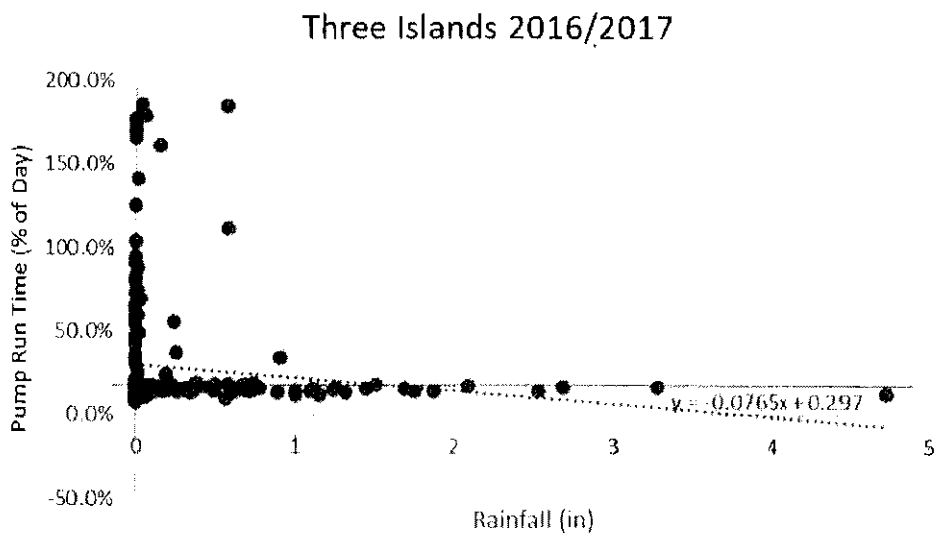
Figure 3.20 – Inflow for 2016-2017 – the regression slope is negative, but note some early high run times. The actual slope (solid line) slope indicates flows increased with rainfall - Lift Station 4 Service Area

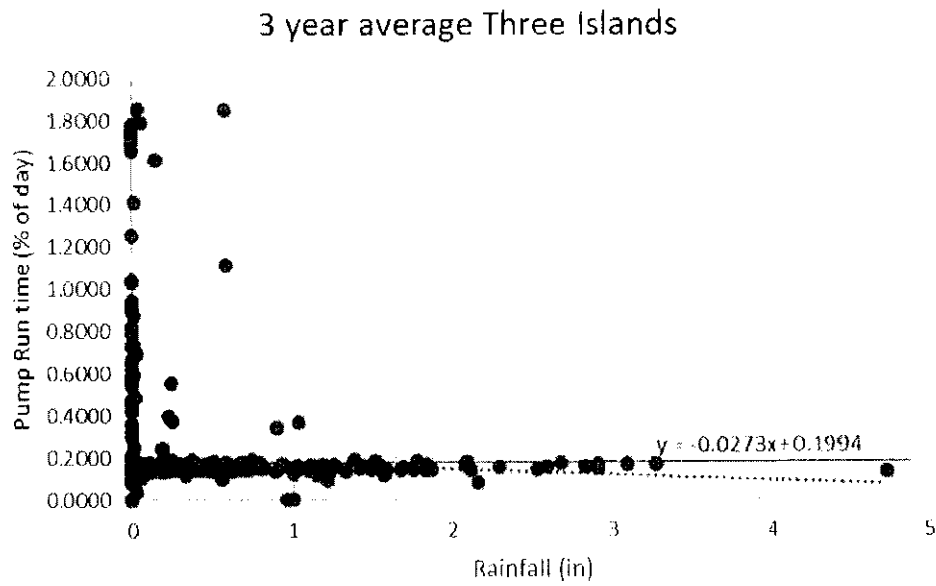
The Lift Station 4 service area contains 10 manholes that were found, GPSed and sealed. The midnight run indicated points where infiltration as noted (see map in Appendix A). A review of rainfall versus flows from July 1, 2014 to June 30, 2017 indicates an increasing slope that indicates flows increased with rainfall n2014-2015 (Figure 3.18). The data for 2015-2016 is suspect as one of the pumps was not registering during the year (Figure 3.19). Inflow for 2016-2017 – the regression slope is negative but note some early high run times (Figure 3.20). The average graphic for Inflow for 2014-2017 – the slope indicates the system is tight (Figure 3.21). The average pumps times increased from 2014 to 2017 (for 15 to over 29%).

Figure 3.21 – Average graphic for Inflow for 2014-2017 – the slope indicates the system is fairly tight. - Lift Station 4 Service Area

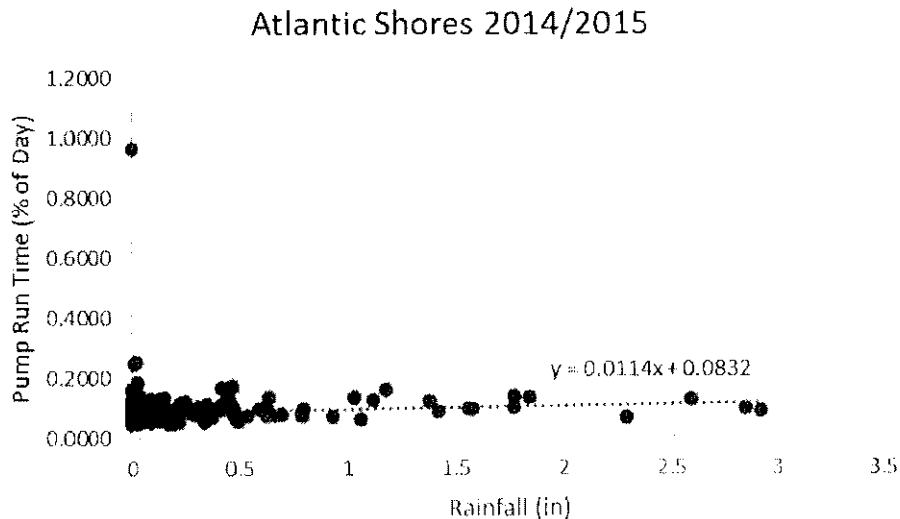
Figure 3.23 – Inflow for 2014-2015 – the increasing slope indicates flows increased with rainfall  
- Lift Station 5 Service Area

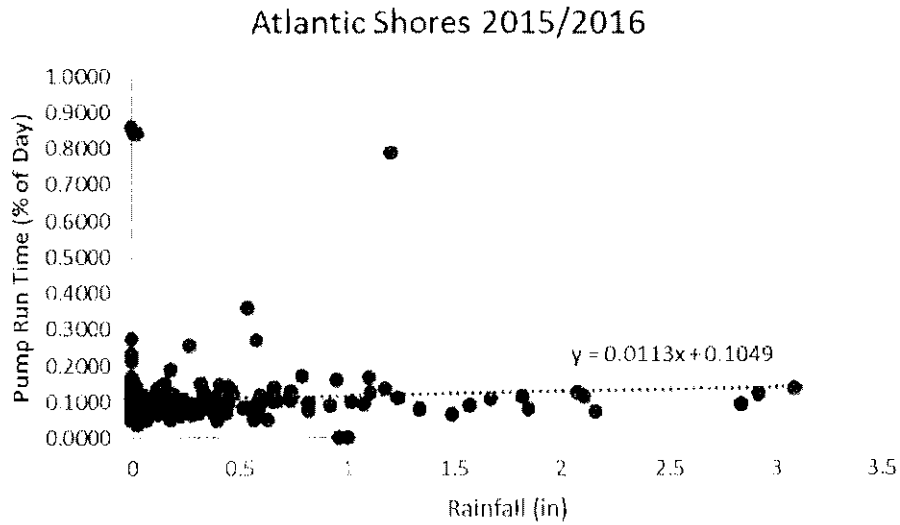
Figure 3.24– Inflow for 2015-2016 – the increasing slope indicates flows increased with rainfall - Lift Station 5 Service Area

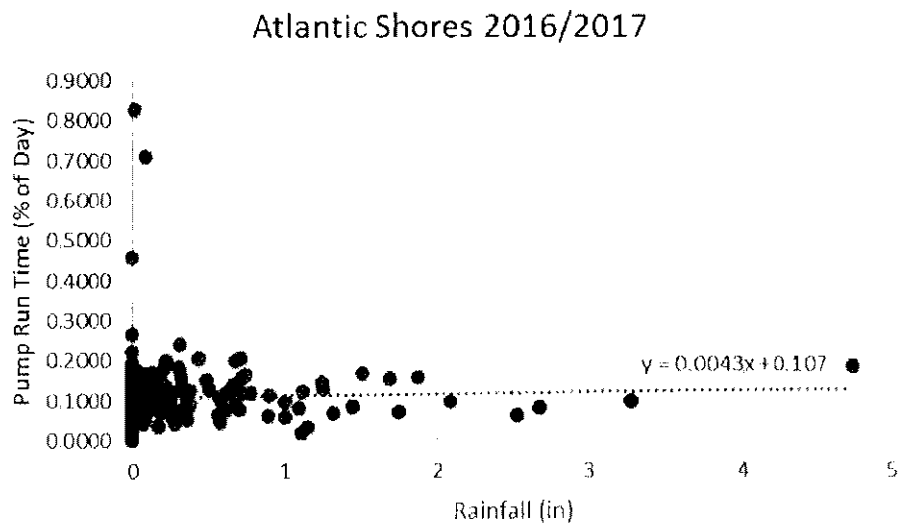
Figure 3.25 – Inflow for 2016-2017 – the regression slope is negative, but note some early high run times. The actual slope (solid line) slope indicates flows increased with rainfall - Lift Station 5 Service Area

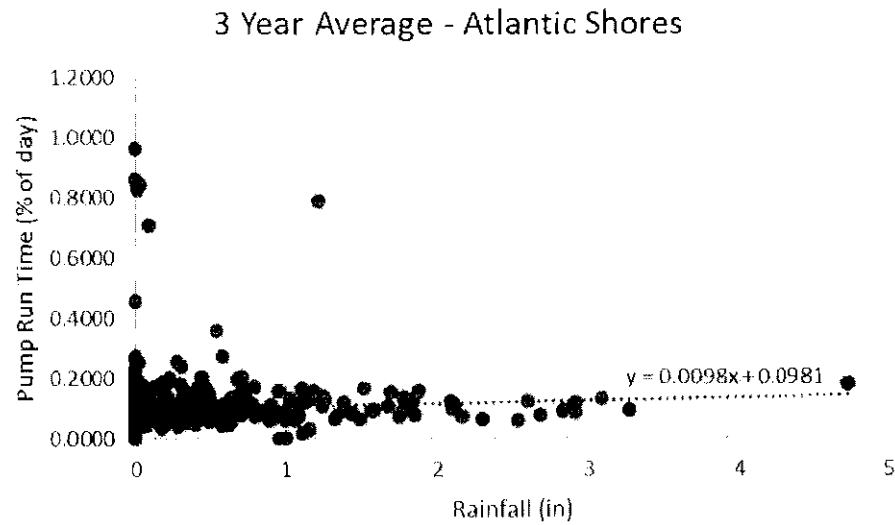
The Lift Station 5 service area contains 8 manholes that were found, GPSed and sealed. The midnight run indicated points where infiltration as noted (see map in Appendix A). A review of rainfall versus flows from July 1, 2014 to June 30, 2017 indicates that the slope of the line is increasing, indicating inflow volumes are increasing each year (see Figures 3.23-3.25). The overall trend indicates inflow is present (see Figure 3.26). The average pumps times increased from 2014 to 2017 (to 9.8%).

Figure 3.26 – Average graphic for Inflow for 2014-2017 – the increasing slope indicates flows increased with rainfall - Lift Station 5 Service Area

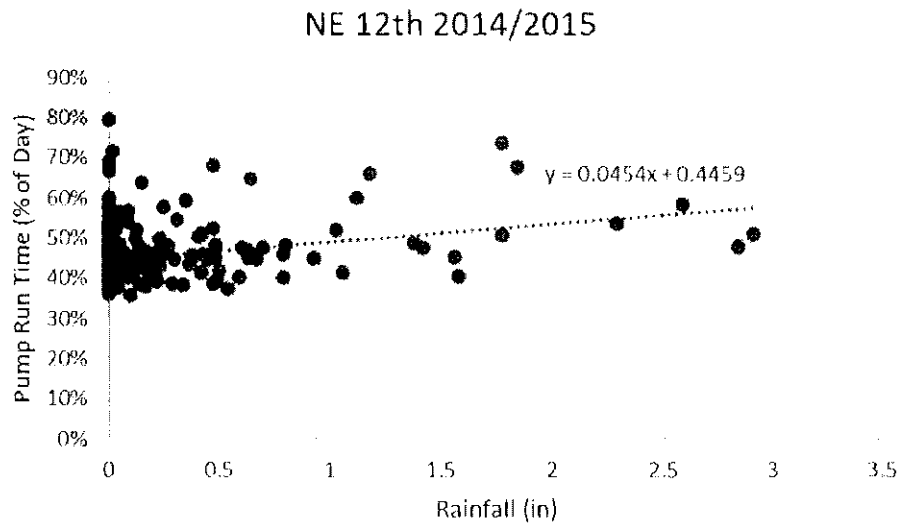
Figure 3.29– Inflow for 2014-2015 – the increasing slope indicates flows increased with rainfall  
- Lift Station 6 Service Area

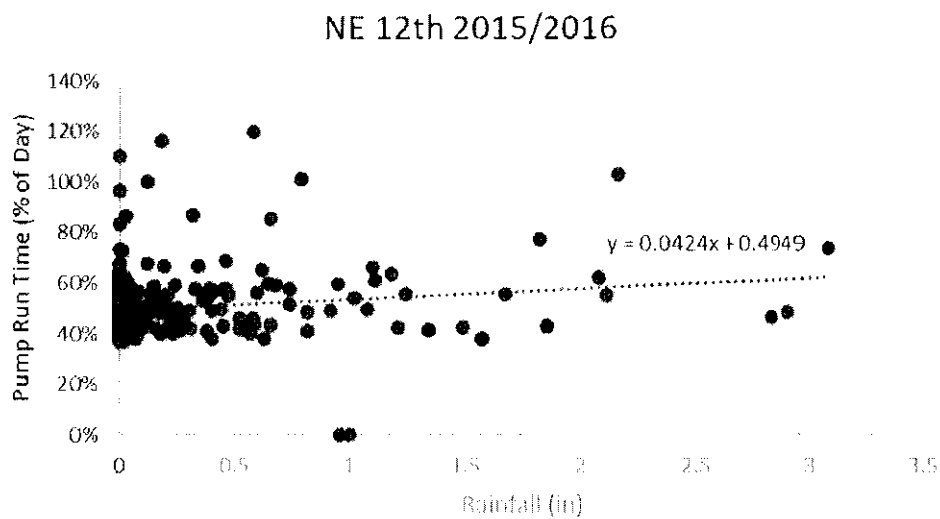
Figure 3.30– Inflow for 2015-2016 – the increasing slope indicates flows increased with rainfall  
- Lift Station 6 Service Area

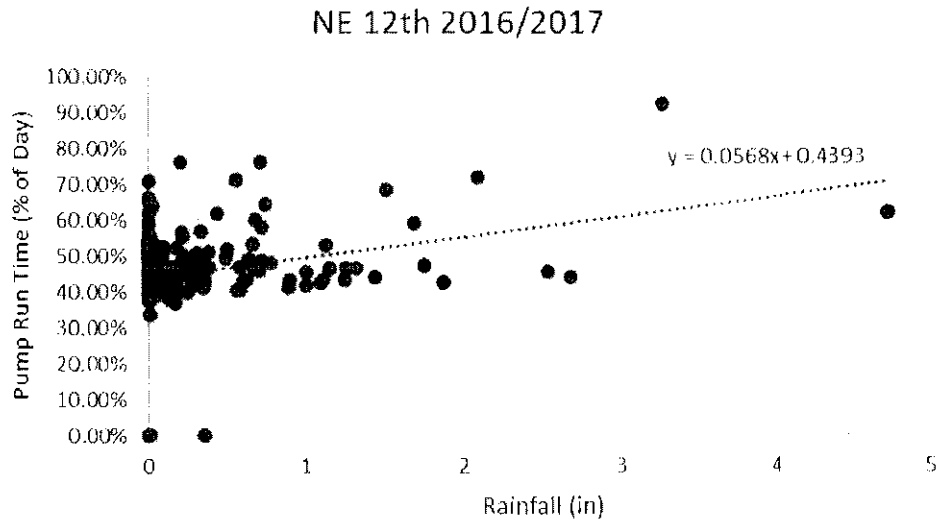
Figure 3.31 – Inflow for 2016-2017 – the regression slope is negative, but note some early high run times. The actual slope (solid line) slope indicates flows increased with rainfall - Lift Station 6 Service Area

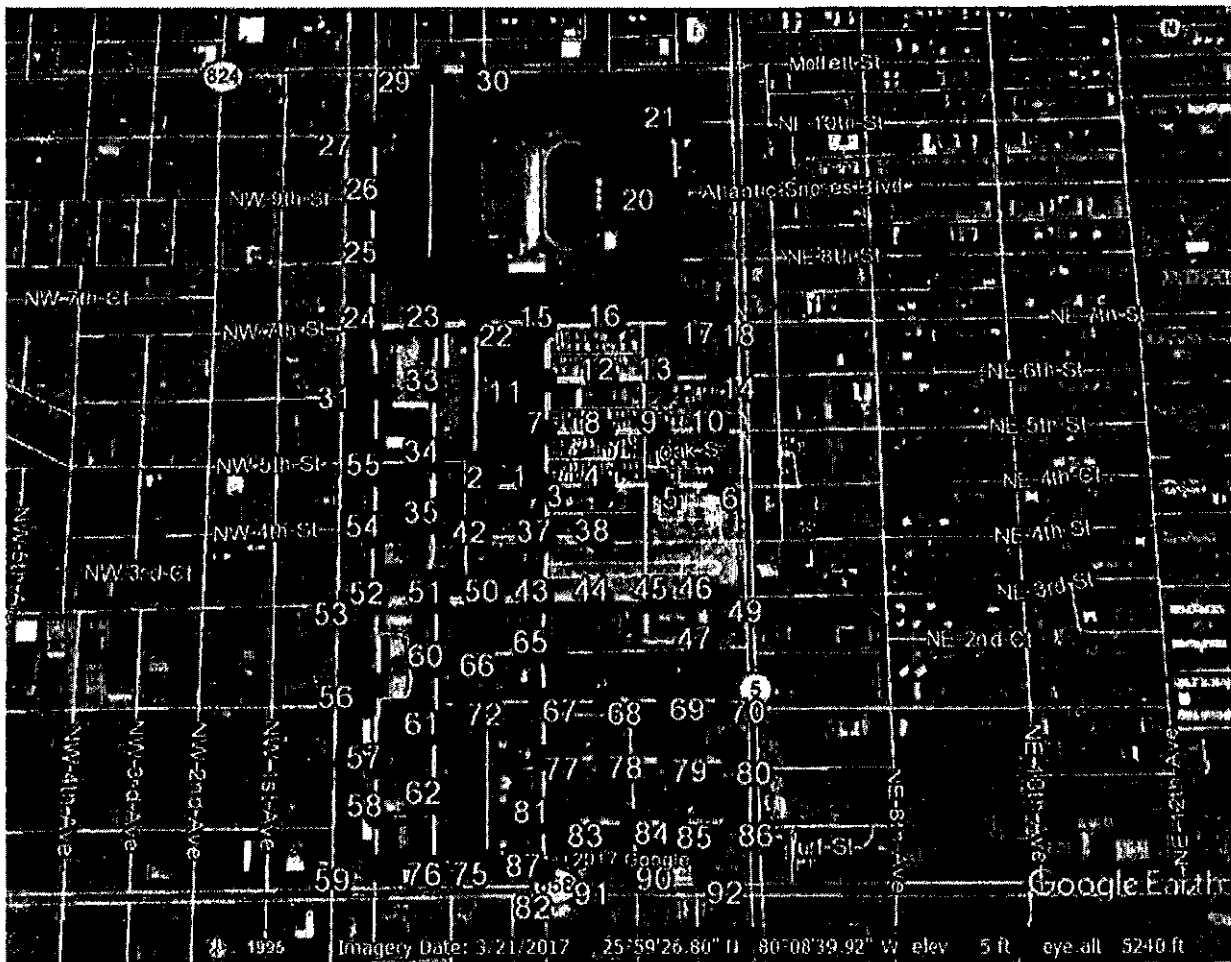
Figure 3.39 – Manholes GPSed - Lift Station 7 Service Area

Figure 3.39 shows the manhole locations. With respect to the manhole construction types, 2 were precast and 81 were brick. None had steps. All manhole covers and rings were cast iron. A number of the manhole covers have pick-holes (see Table 3.11). Most of the manholes (45) were in good condition. There were 36 manholes in average condition and two in poor or very poor condition (#32 and 92). Manhole #92 is full of grease. These manholes need to be addressed in Phase 2. Manhole #32 has roots in the invert. These manholes need to be addressed in Phase 2. The inverts of manholes #1, 7, 37 and 43 were submerged. There is a dish in the bottom of Manhole #59.

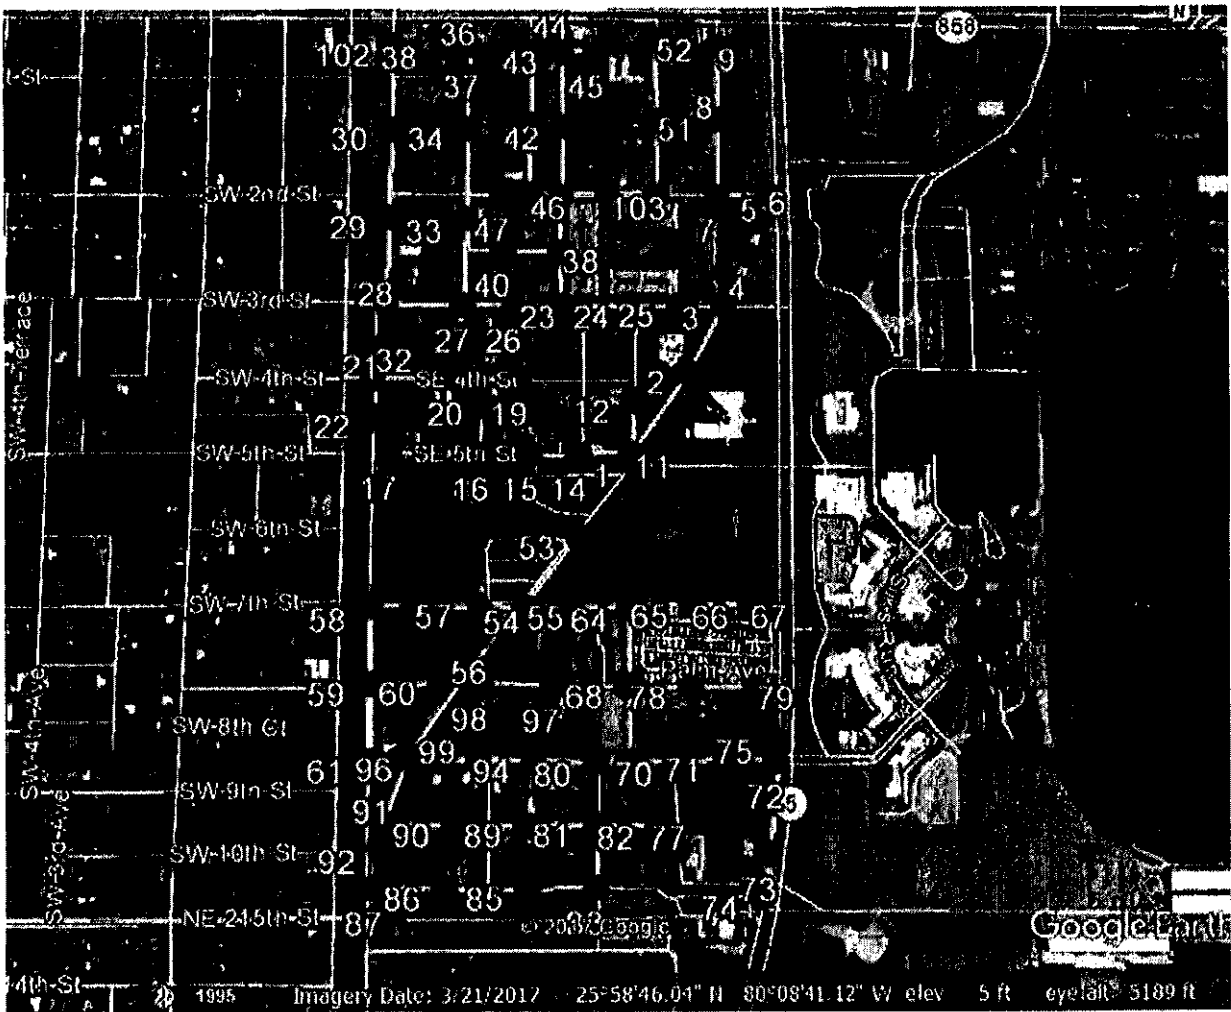
Figure 3.45 – Manholes GPSed - Lift Station 8 Service Area

Figure 3.45 shows the manhole locations. With respect to the manhole construction types, 35 were precast and 60 were brick. None had steps. All manhole covers and rings were cast iron. A number of the manhole covers have pick-holes (see Table 3.13). None had steps. Most of the manholes (94) were in good condition. There was 1 manhole in average condition and none in poor or very poor condition. The inverts of manholes #1, 2, 6, 11, 55, and 72-75 were submerged.

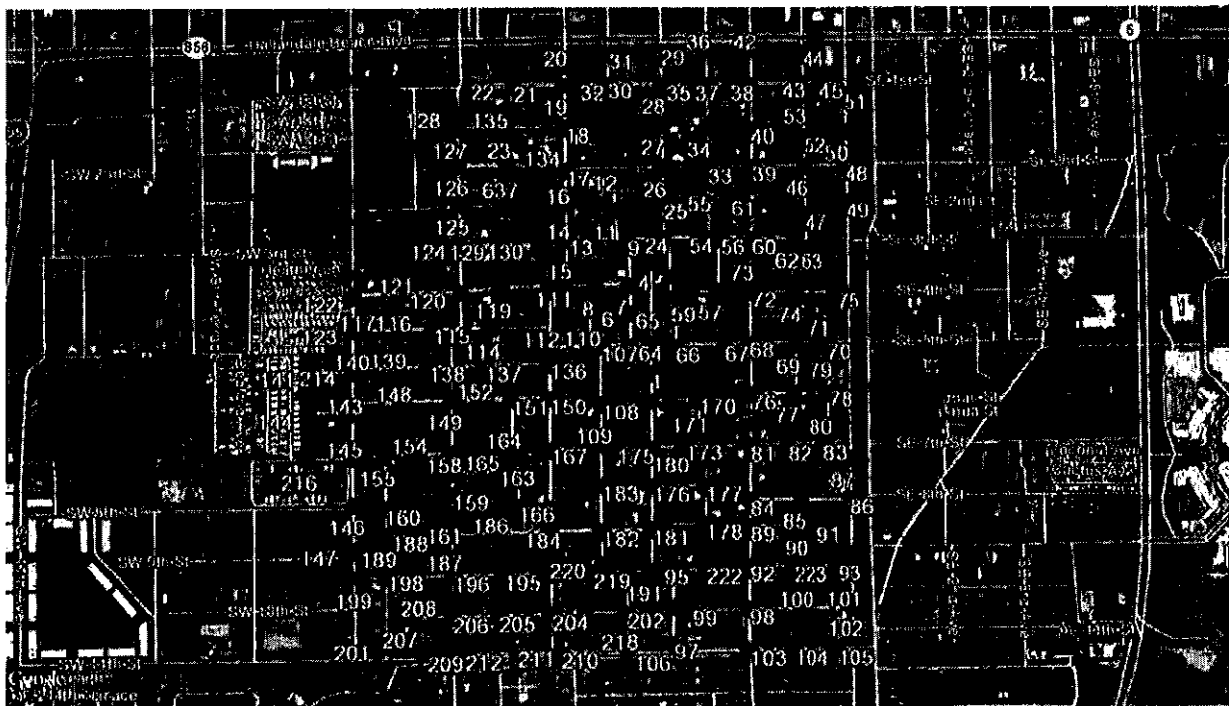
Figure 3.72 – Manholes GPSed - Lift Station 12 Service Area

Figure 3.72 shows the manhole locations. With respect to the manhole construction types, all were precast. None had steps. All manhole covers and rings were cast iron. A number of the manhole covers have pick-holes (see Table 3.19). None had steps. Most of the manholes (167) were in good condition. There were 45 manholes in average condition and one in poor or very poor condition. Manhole #84 has leaks in the walls and should be addressed in Phase 2. The inverts of manholes #1, 2, 6, and 64 were submerged.

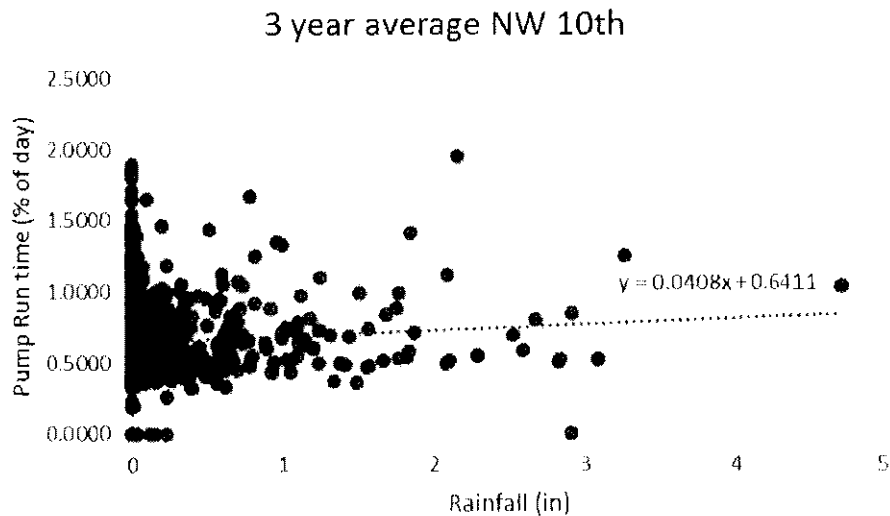
The Lift Station 14 service area contains 83 manholes that were found, GPSed and sealed. The midnight run indicated points where infiltration as noted (see map in Appendix A). A review of rainfall versus flows from July 1, 2014 to June 30, 2017 indicates that the slope of the line is increasing each year, indicating inflow volumes are increasing (see Figures 3.80, 3.82 and 3.83). The year 2015-2016 did not show this trend, but there were some very large zero rainfall flows that impact the trend line. Overall flows for the service area were greater than the subsequent year, but much higher than the prior. There were 33 openings found on the system, confirming the inflow. The overall trend indicates inflow is present (see Figure 3.83). The average pumps times increased from 2014 to 2017 (44 to 72.5%).

Figure 3.83 – Average graphic foe Inflow for 2014-2017 – the increasing slope indicates flows increased with rainfall - Lift Station 14 Service Area

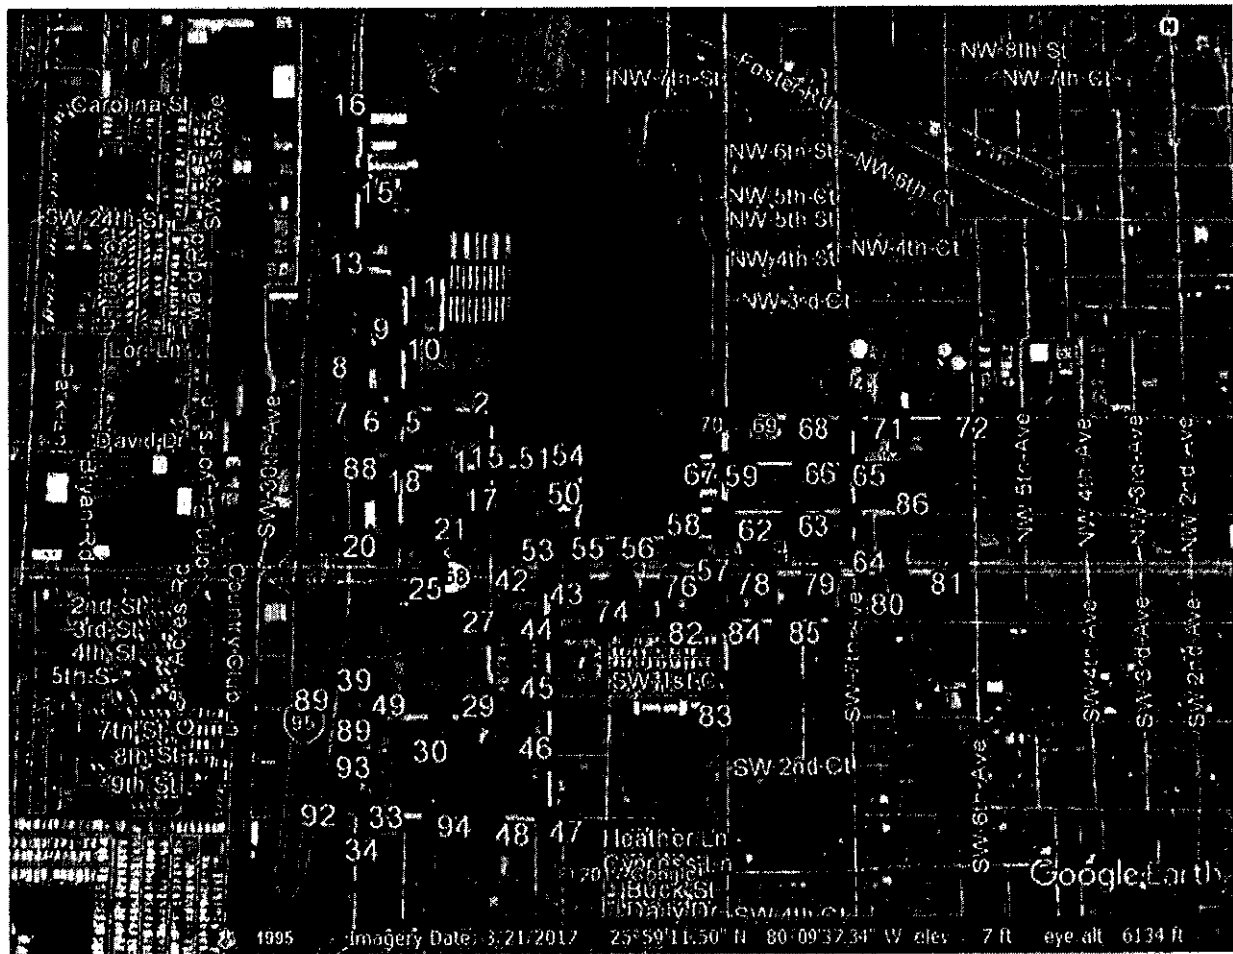
Figure 3.84 shows the manhole locations. With respect to the manhole construction types, 81 were precast and 2 were brick. Four had steps, three in good condition. The steps in Manhole #34 need repairs. All manhole covers and rings were cast iron. A number of the manhole covers have pick-holes (see Table 3.24). There were 31 manholes were in good condition. There were 52 manholes in average condition and none were in poor or very poor condition. Manhole 23 needs the grease to be removed.

Figure 3.84 – Manholes GPSed - Lift Station 14 Service Area

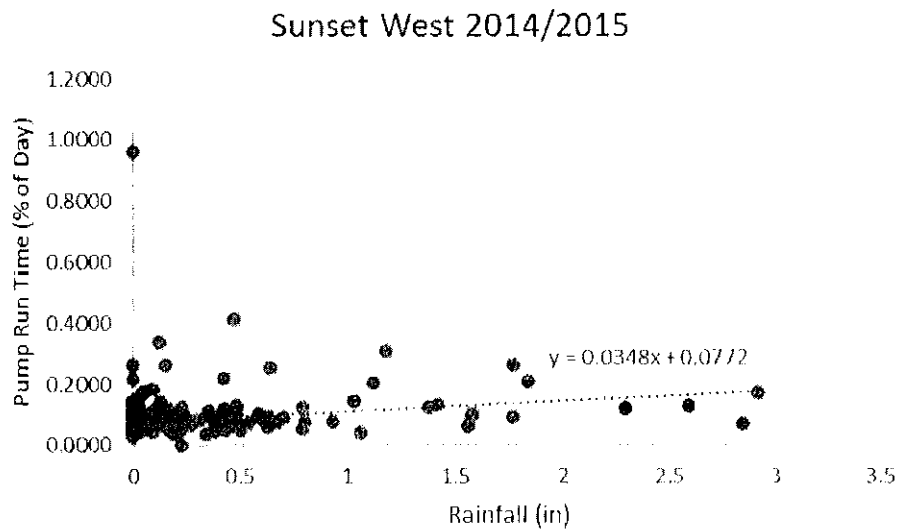
Figure 3.86 – Inflow for 2014-2015 – the increasing slope indicates flows increased with rainfall  
- Lift Station 15 Service Area

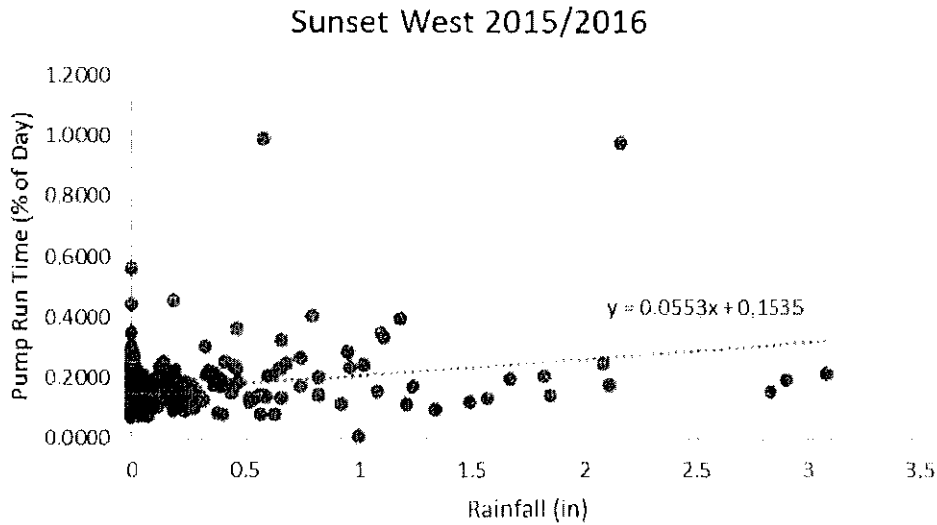
Figure 3.87 – Inflow for 2015-2016 – the increasing slope indicates flows increased with rainfall - Lift Station 15 Service Area

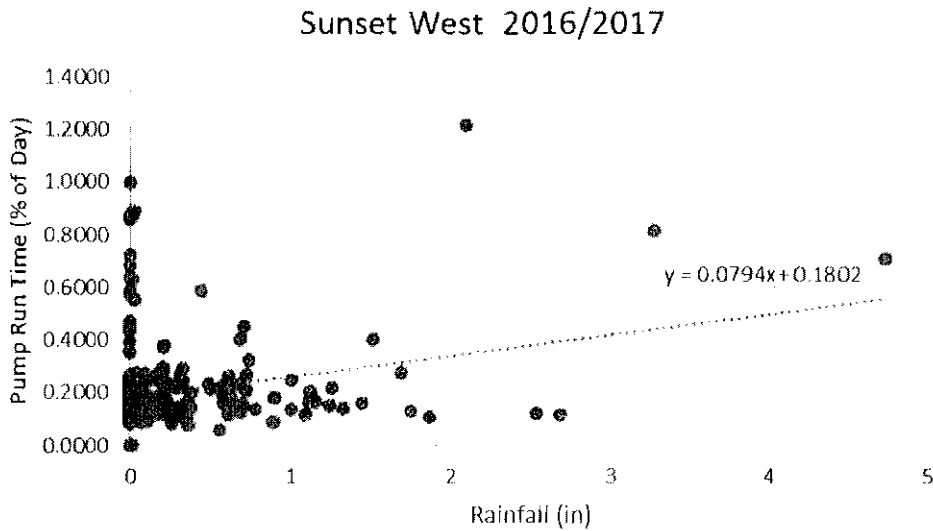
Figure 3.88 – Inflow for 2016-2017 – the regression slope is positive, but note some early high run times. The actual slope (solid line) slope indicates flows increased with rainfall- Lift Station 15 Service Area

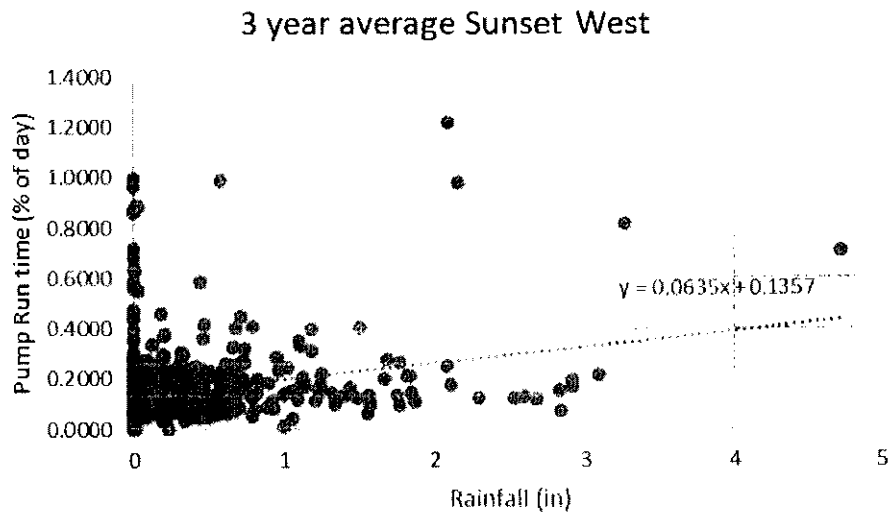
The Lift Station 15 service area contains 4 manholes listed as Area 1-29 to 32 on the City's map and are hence included in that service area. See Lift Station #1 service area for details on these manholes. No inflow was noted. The midnight run showed no excessive infiltration. A review of rainfall versus flows from July 1, 2014 to June 30, 2017 indicates that the slope of the line is increasing each year, indicating inflow volumes are increasing (see Figures 3.86-3.88). There were no openings found on the system. The overall trend indicates inflow is present (see Figure 3.89). The average pumps times increased from 2014 to 2017 (7.7 to 18%).

Figure 3.89 – Average graphic foe Inflow for 2014-2017 – the increasing slope indicates flows increased with rainfall - Lift Station 15 Service Area
