## SSSES PHASE I

## CITY OF HALLANDALE BEACH, FLORIDA

FY 2018

DEP Clean Water SRF Project No. \*\*\*

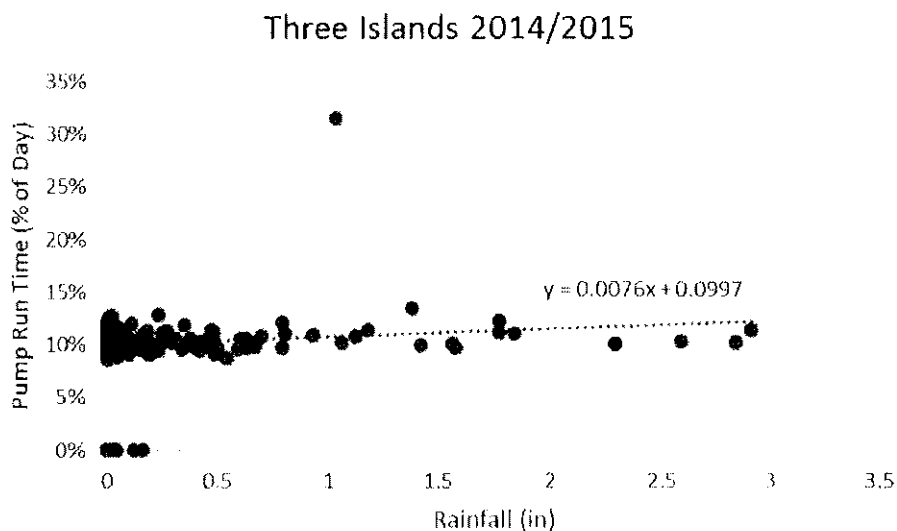
The Lift Station 18 service area contains 11 manholes that were found, GPSed and sealed. The midnight run indicated points where infiltration as noted (see map in Appendix A). A review of rainfall versus flows from July 1, 2014 to June 30, 2017 indicates that the slope of the line was increasing the first year (Figure 3.90), but is fairly flat thereafter (Note there is missing data and some very high flows that distort the trend. (see Figures 3.91 and 3.92 and solid trend line). This matches with finding no openings during smoke testing and being a small basin. The overall trend indicates little inflow is present (see Figure 3.93). The average pumps times doubled from 2014 to 2017.

Figure 3.90 – Inflow for 2014-2015 – the increasing slope indicates flows increased with rainfall  
- Lift Station 18 Service Area

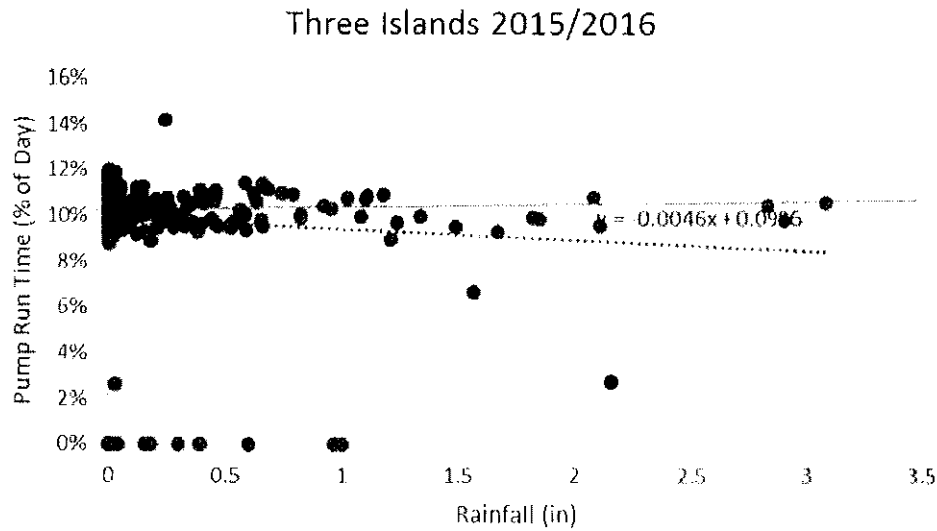
Figure 3.91 – Inflow for 2015-2016 – the increasing slope indicates flows increased with rainfall - Lift Station 18 Service Area

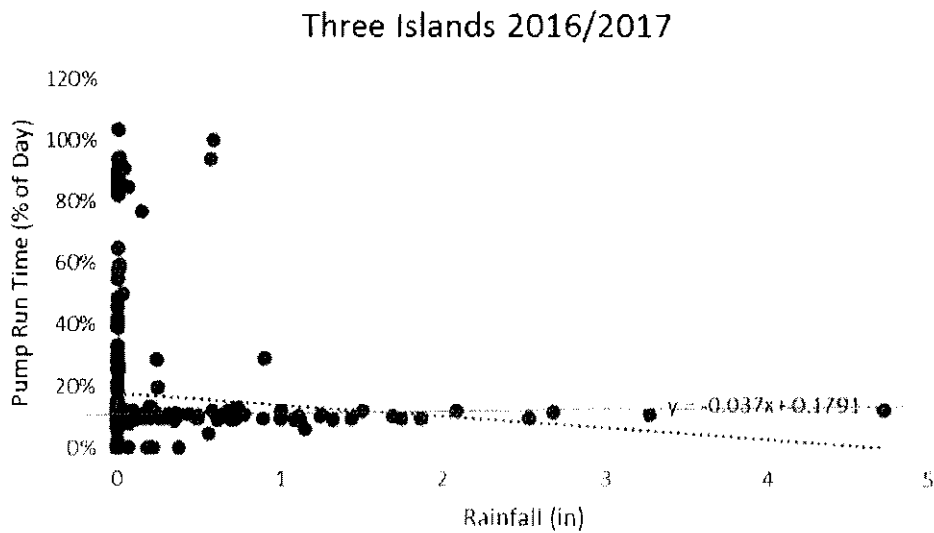
Figure 3.92 – Inflow for 2016-2017 – the regression slope is negative, but note some early high run times. The actual slope (solid line) slope indicates flows increased with rainfall- Lift Station 18 Service Area

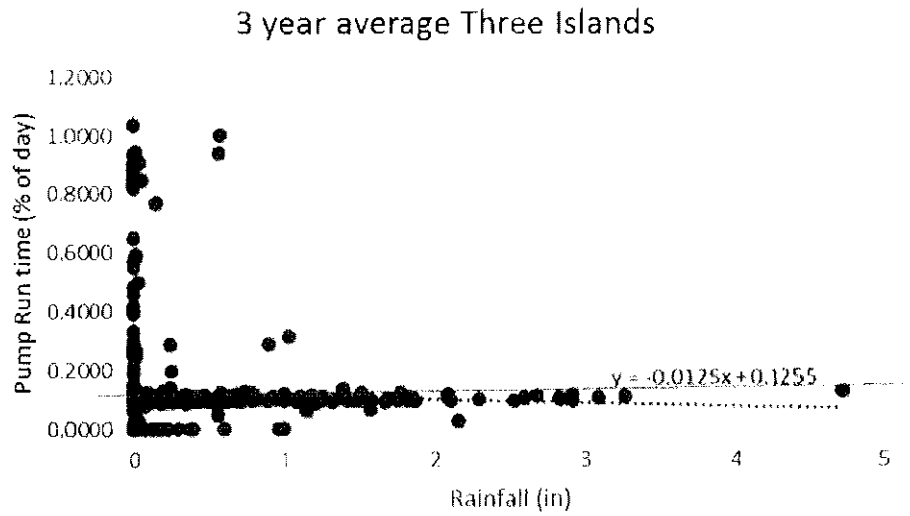
Figure 3.93 – Average graphic foe Inflow for 2014-2017 – the increasing slope indicates flows increased with rainfall - Lift Station 18 Service Area
