SSES PHASE I

CITY OF HALLANDALE BEACH, FLORIDA

FY 2018

DEP Clean Water SRF Project No. ***

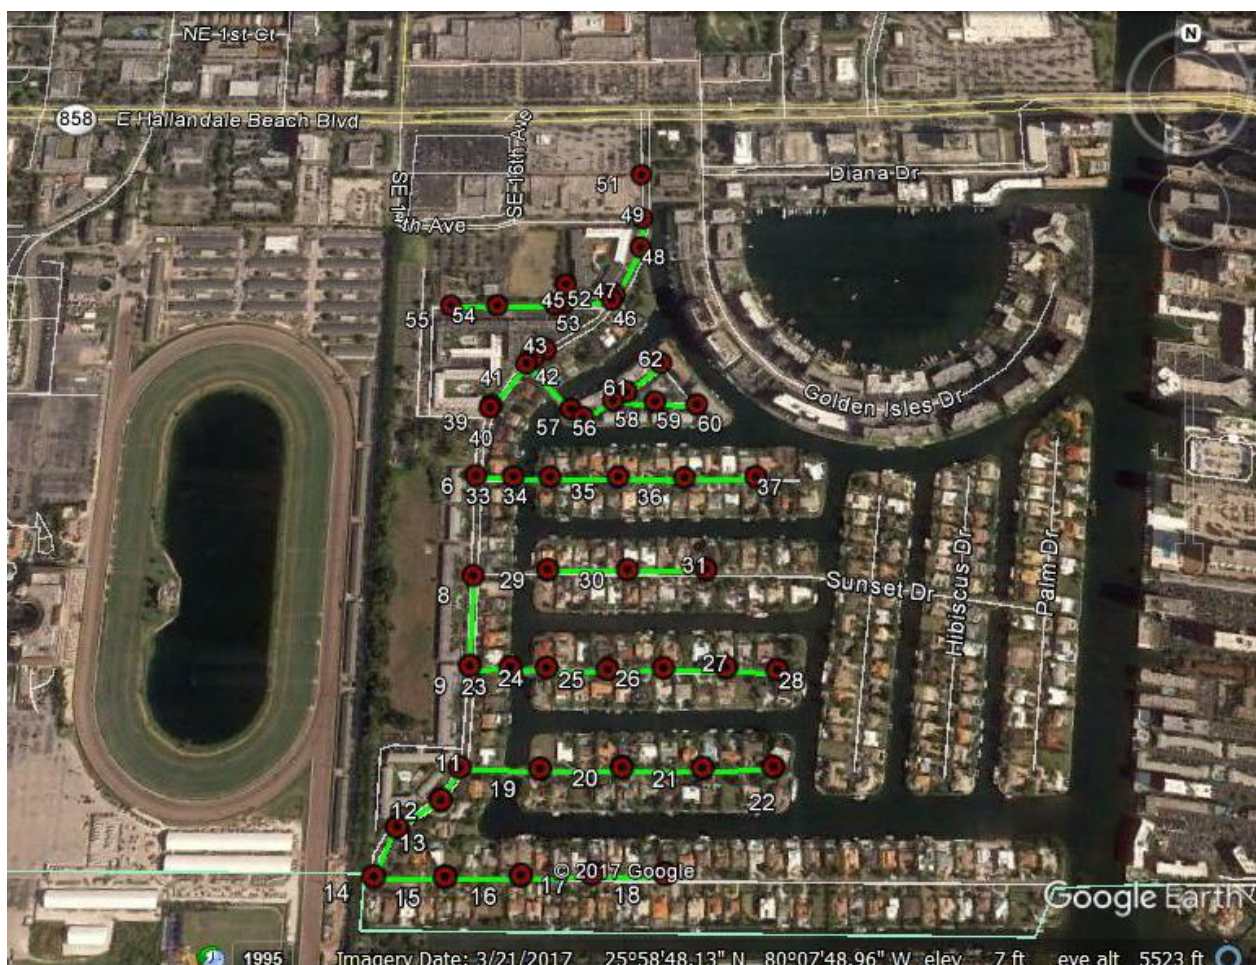
Figure 3.5 – Manholes GPSed - Lift Station 1 Service Area

at the walls by the invert– 33, 51 and 56. Manhole 56 was in poor condition and had a leak. This manhole needs to be addressed in Phase 2. Figure 3.5 shows the manhole locations.

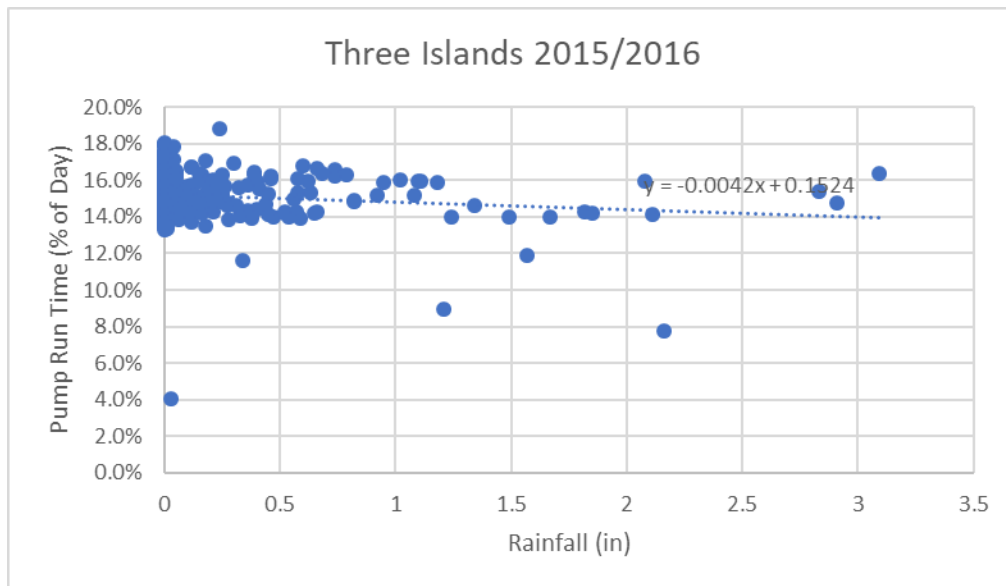
Figure 3.19– Inflow for 2015-2016 – The data is suspect as one of the pumps was not registering during the year. - Lift Station 4 Service Area

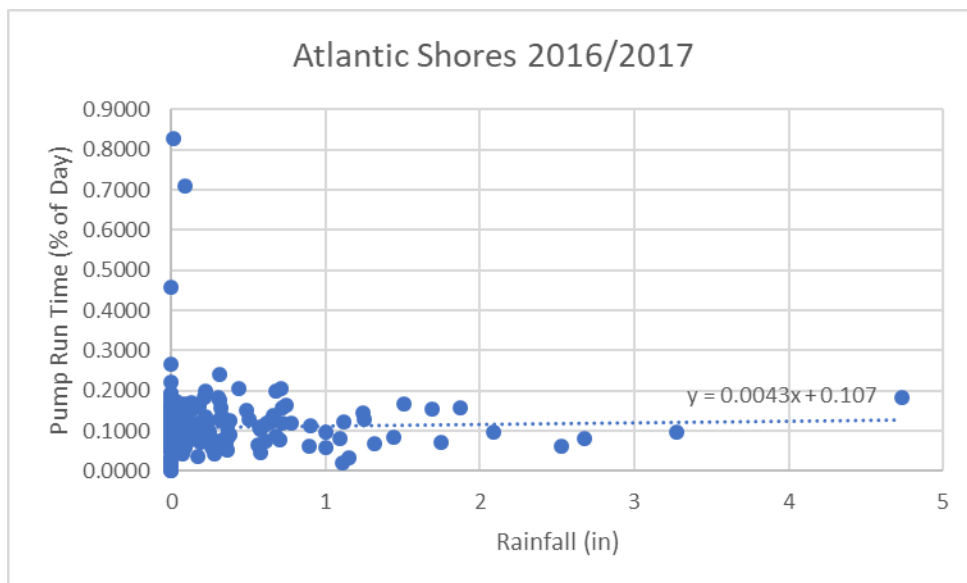
Figure 3.25 – Inflow for 2016-2017 – the regression slope is negative, but note some early high run times. The actual slope (solid line) slope indicates flows increased with rainfall - Lift Station 5 Service Area

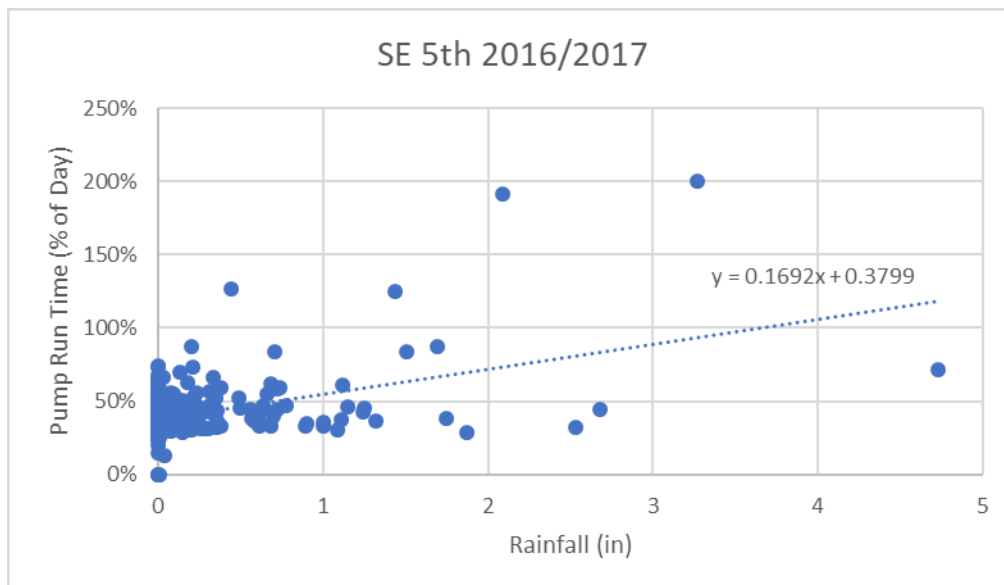
Figure 3.43 – Inflow for 2016-2017 – the regression slope is positive, but note some early high run times. The actual slope (solid line) slope indicates flows increased with rainfall - Lift Station 8 Service Area

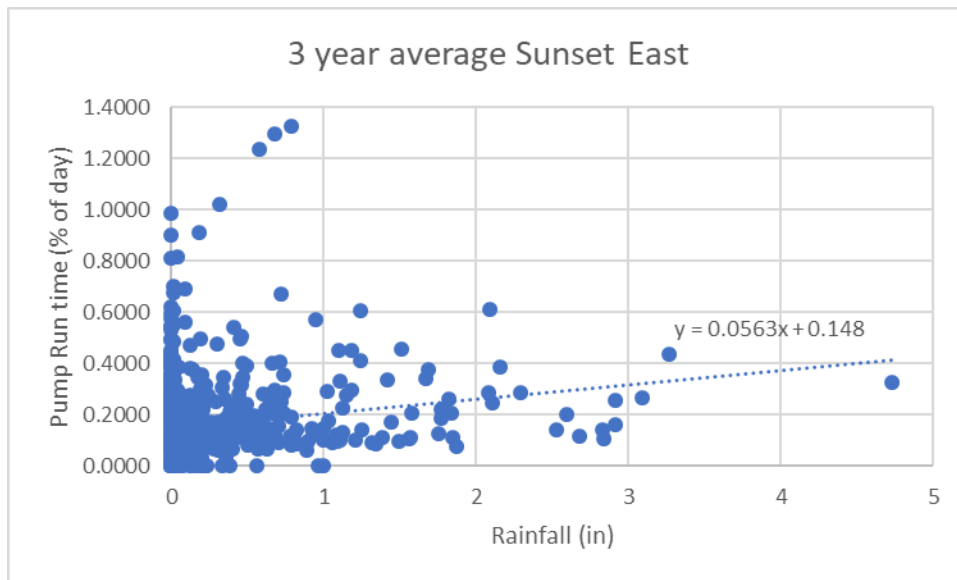
Figure 3.55 – Inflow for 2016-2017 – the regression slope is negative, but note some early high run times. The actual slope (solid line) slope indicates flows increased with rainfall - Lift Station 10 Service Area

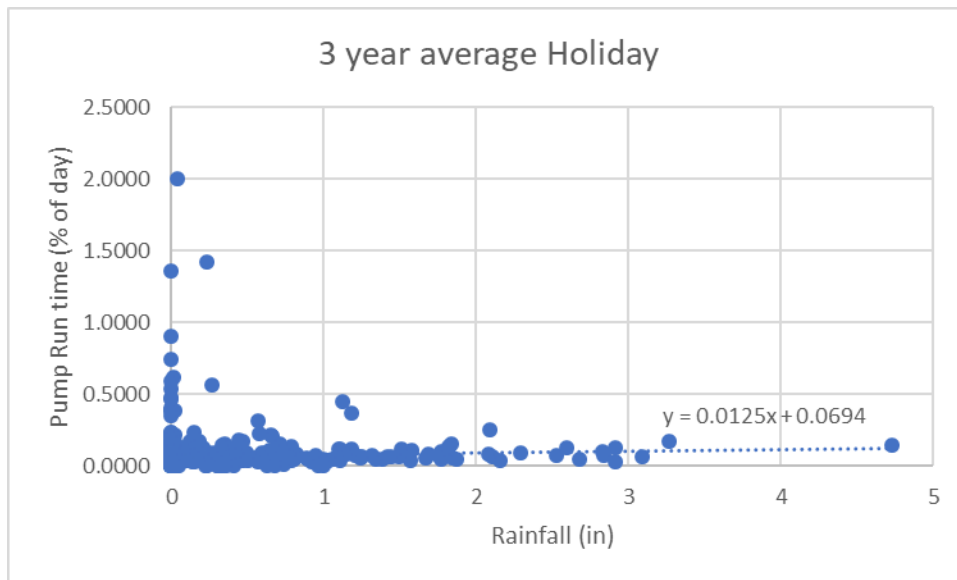
Figure 3.65 – Inflow for 2016-2017 – the regression slope is negative, but note some early high run times. The actual slope (solid line) slope indicates flows increased with rainfall - Lift Station 11 Service Area

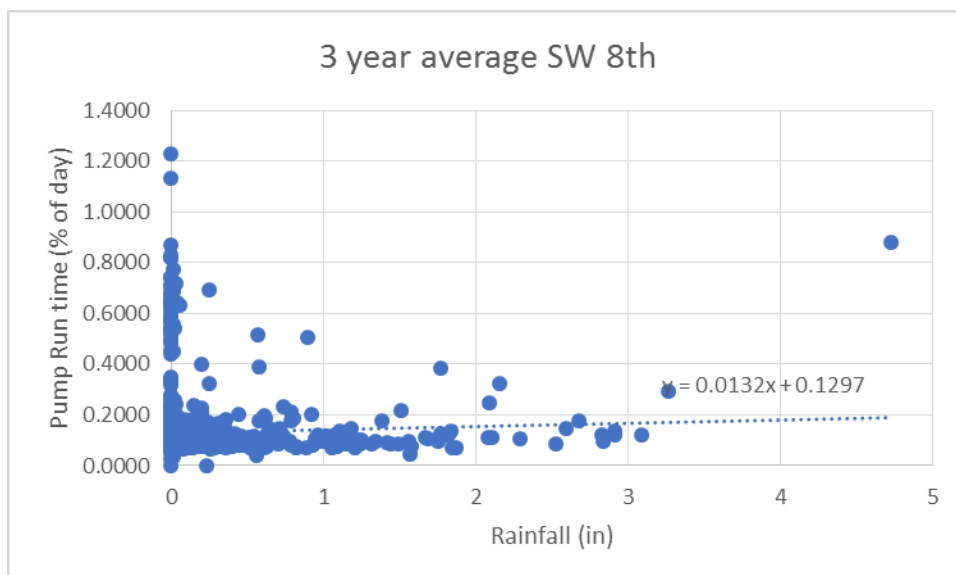
Figure 3.76 – Inflow for 2016-2017 – the regression slope is negative, but note some early high run times. The actual slope (solid line) slope indicates flows increased with rainfall - Lift Station 13 Service Area

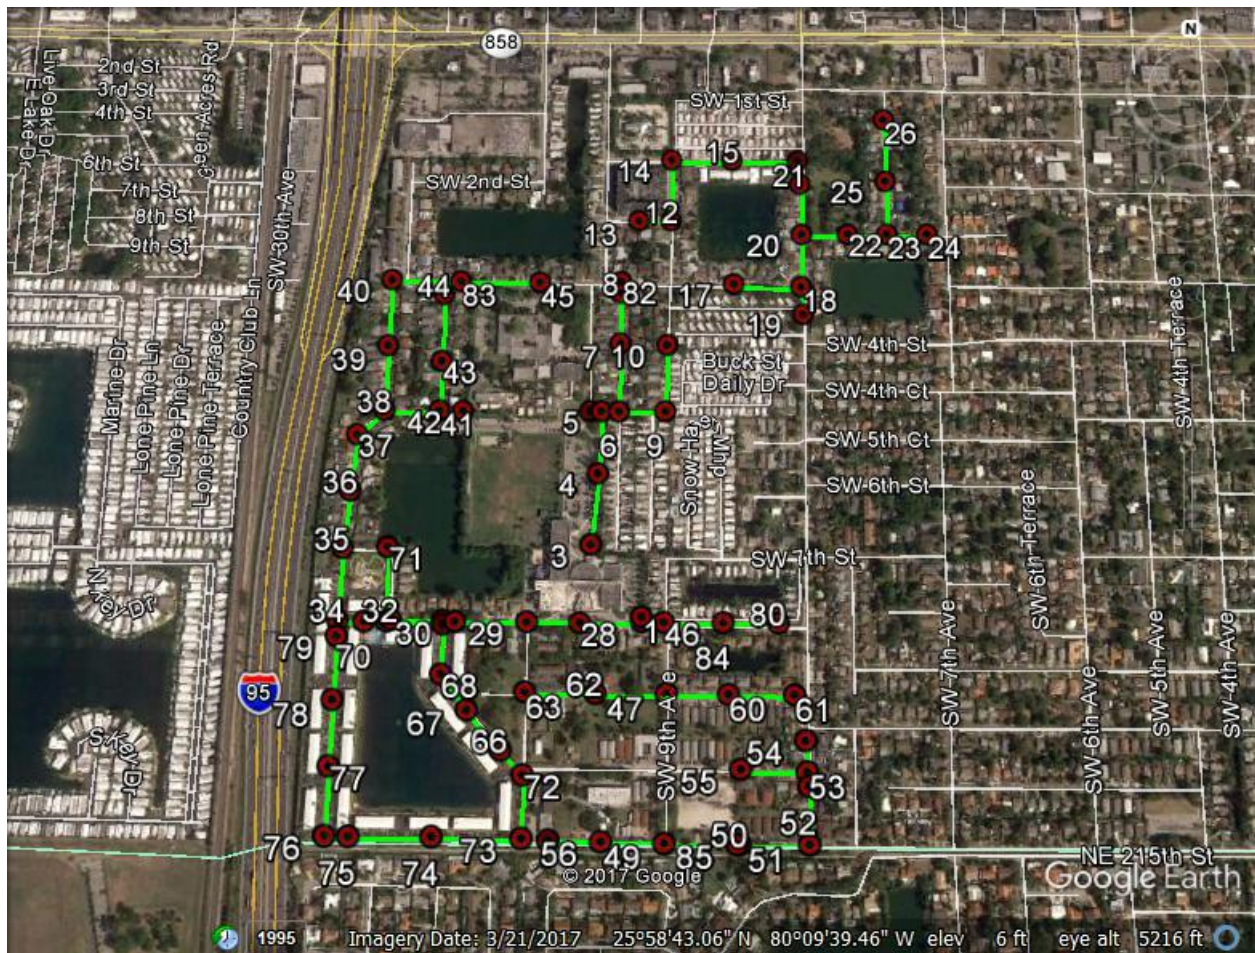
The Lift Station 13 service area contains 82 manholes that were found, GPSed and sealed. The midnight run indicated points where infiltration as noted (see map in Appendix A). A review of rainfall versus flows from July 1, 2014 to June 30, 2017 indicates that the slope of the line is increasing each year, indicating inflow volumes are increasing (see Figure 3.74). The years 2015-2017 the increasing relationship exists, but the slope was less – due to some early high flows at zero rain each year (see Figures 3.75 and 3.76). These need further investigation. When these are removed, the same high trend is noted. There were 19 openings found on the system, confirming the inflow. The overall trend indicates inflow is present (see Figure 3.77). The average pumps times increased from 2014 to 2017 (10 to 18.9%).

Figure 3.77 – Average graphic foe Inflow for 2014-2017 – the increasing slope indicates flows increased with rainfall - Lift Station 13 Service Area

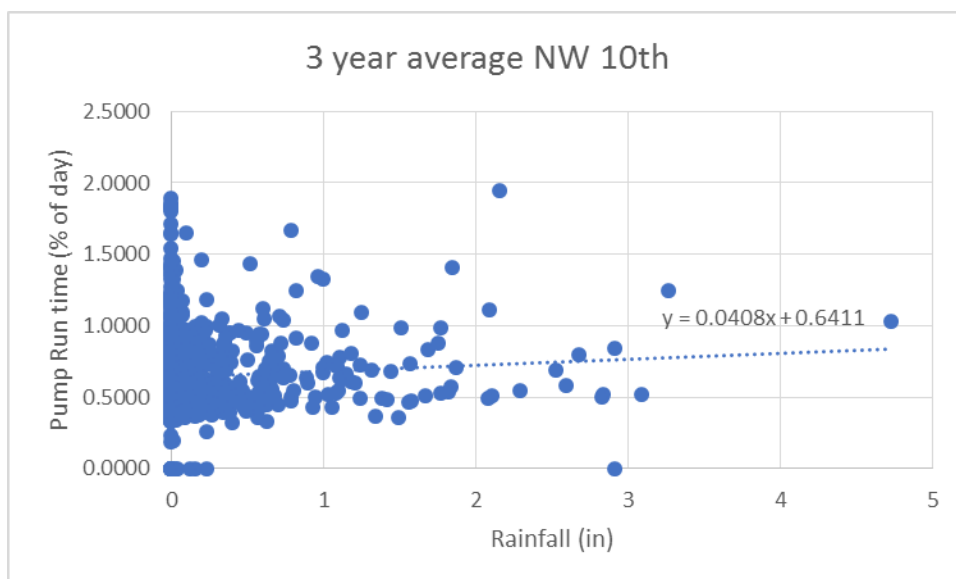
Figure 3.82 – Inflow for 2016-2017 – the regression slope is negative, but note some early high run times. The actual slope (solid line) slope indicates flows increased with rainfall - Lift Station 14 Service Area

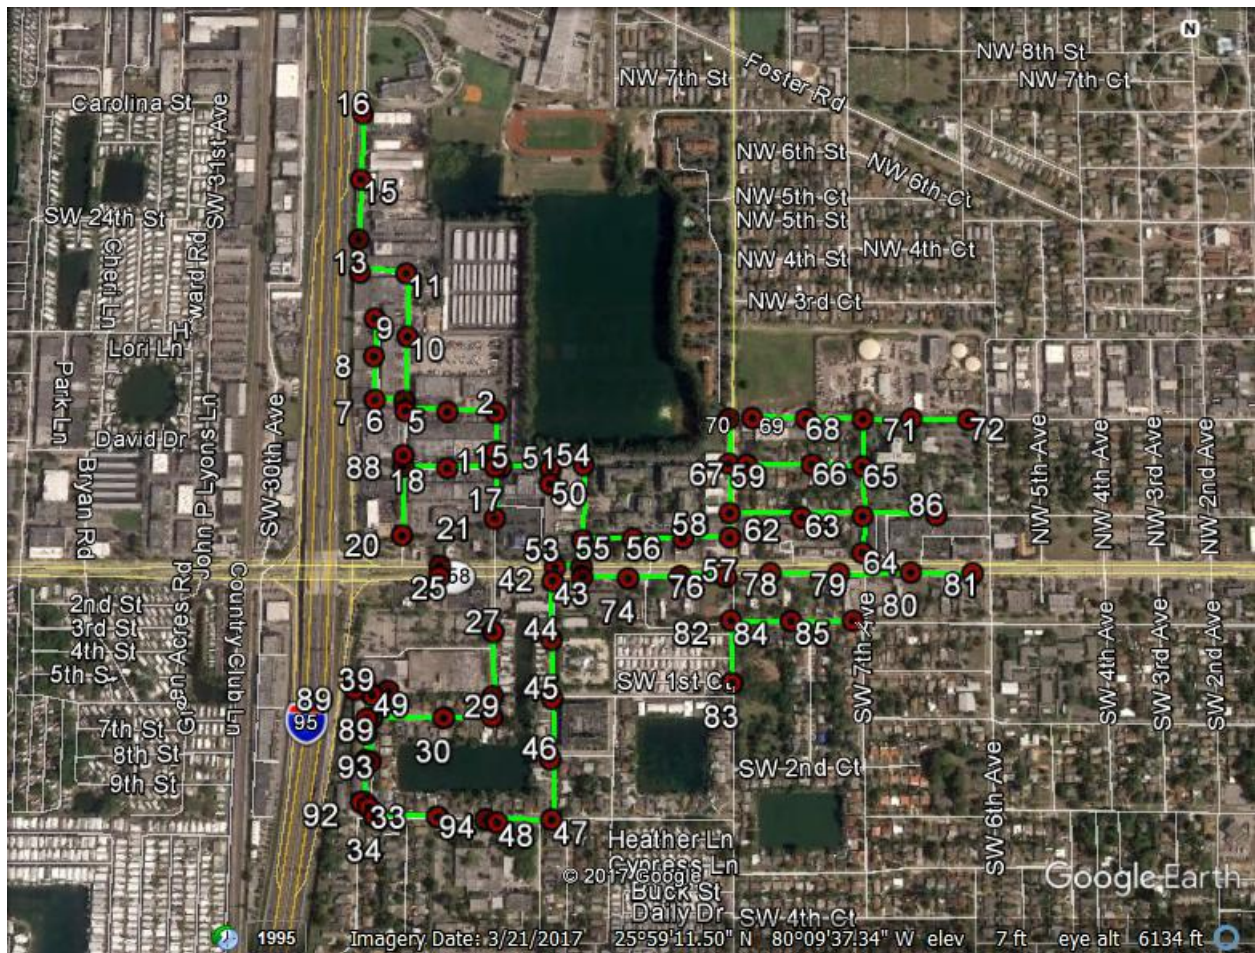
The Lift Station 14 service area contains 83 manholes that were found, GPSed and sealed. The midnight run indicated points where infiltration as noted (see map in Appendix A). A review of rainfall versus flows from July 1, 2014 to June 30, 2017 indicates that the slope of the line is increasing each year, indicating inflow volumes are increasing (see Figures 3.80, 3.82 and 3.83). The year 2015-2016 did not show this trend, but there were some very large zero rainfall flows that impact the trend line. Overall flows for the service area were greater than the subsequent year, but much higher than the prior. There were 33 openings found on the system, confirming the inflow. The overall trend indicates inflow is present (see Figure 3.83). The average pumps times increased from 2014 to 2017 (44 to 72.5%).

Figure 3.83 – Average graphic foe Inflow for 2014-2017 – the increasing slope indicates flows increased with rainfall - Lift Station 14 Service Area

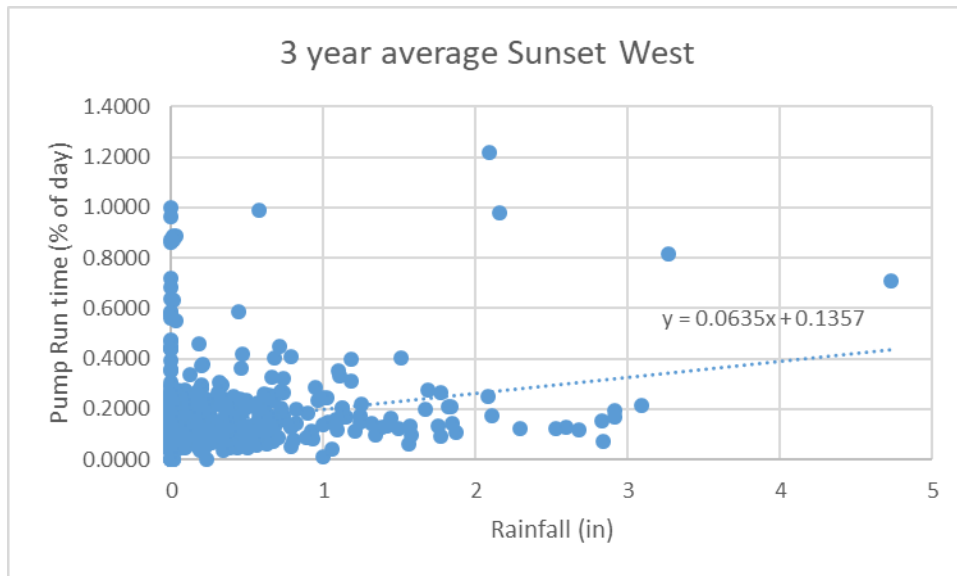
Figure 3.88 – Inflow for 2016-2017 – the regression slope is positive, but note some early high run times. The actual slope (solid line) slope indicates flows increased with rainfall- Lift Station 15 Service Area

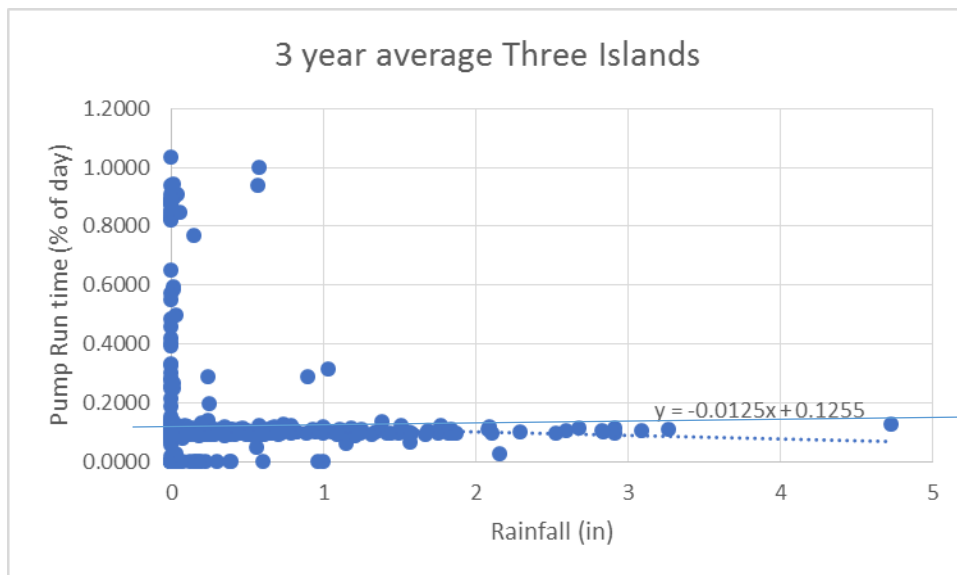
Figure 3.92 – Inflow for 2016-2017 – the regression slope is negative, but note some early high run times. The actual slope (solid line) slope indicates flows increased with rainfall- Lift Station 18 Service Area
